Resilient Home Design for A Coastal Community of Baan Khun Samut Chin, Samutprakan

Srisak Phattanawasin^{1*}, Wisan Boonlue²

Faculty of Architecture and Planning, Thammasat University, Pathumthani 12121, Thailand

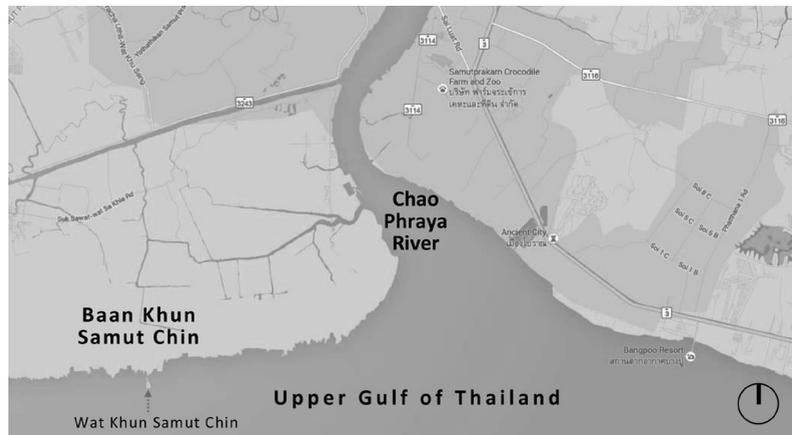
Figure 1. Location of Baan Khun Samut Chin Village in relation to the Chao Phraya River and the Gulf of Thailand (Source: Teamvan, B. (2017))

Located in Phra Samut Chedi district of Samut Prakan province, Baan Khun Samut Chin is a remote coastal community in the Upper Gulf of Thailand (Figure 1). It's just away from the capital Bangkok about 50 kilometers southwest. The settlement of Baan Khun Samut Chin had long started for more than 300 years since Ayutthaya period (Skinner, 1957). Due to its fertile estuary land with high agricultural productivity of Chao Phraya River, most Chinese immigrants decided to set up their trading district here. Later, the government sent an aristocrat to rule over the growing Chinese community, which was later called by the name of "Khun Samut Chin" meaning the lords of Chinese coastal village (Kosit, 2016).

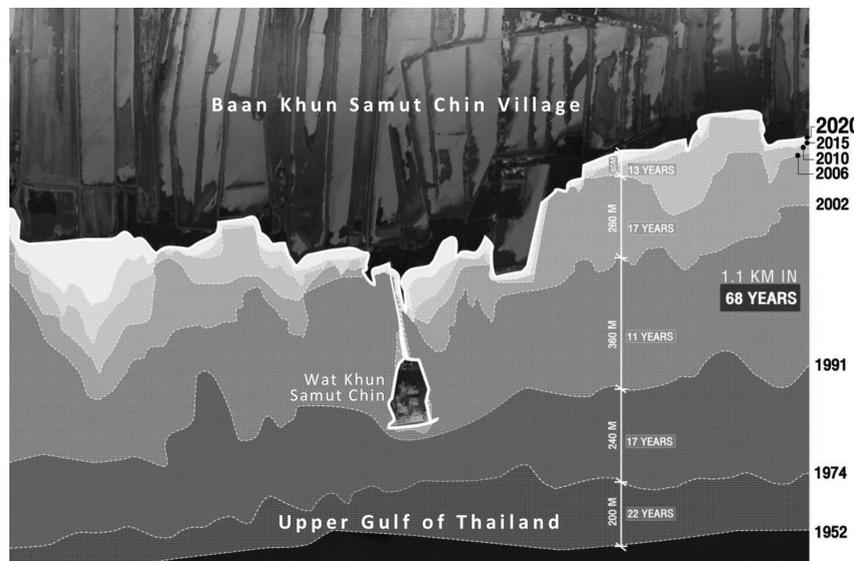
Figure 2. Over the last 68 years the village's land of Baan Khun Samut Chin have been swallowed by the sea almost 1.1 kilometres. It has lost only the community temple, Wat Khun Samut Chin as a reluctant witness to coastal erosion. (Source: Google Earth satellite images modified by authors.)

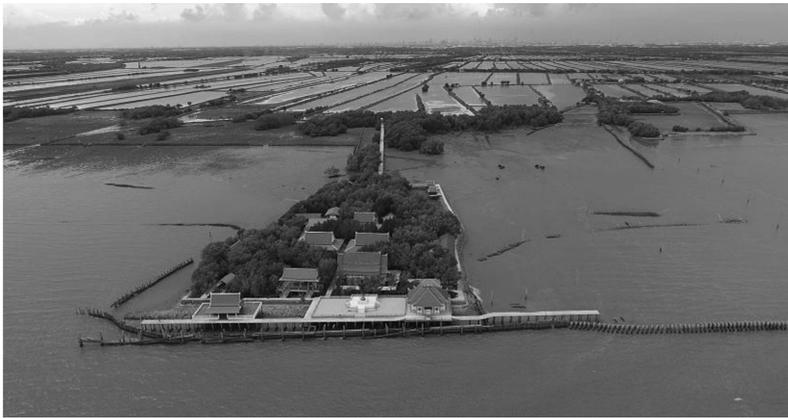
Figure 3. Wat Khun Samut Chin (Wat Khun Samut Trawat) has now become surrounded by the sea due to land erosion. (Source: Barrow, R. (2016) in <https://paknam.com/drone-photos/aerial-photos-of-wat-khun-samut-chin>)

Some of the houses that once stood along the coast are now left only structure in the middle of water. As well as numerous electricity poles that once ran parallel to the shoreline, are now half visible at a great distance from the coast (Figure 4). The community temple, Wat Khun Samut Chin (Wat Khun Samut Trawat) which was once located far inland at the back of the village, is now surrounded by the sea (Figure 3), as a reluctant witness to coastal erosion.

The temple was trapped in the distant water and only connected to the rest of the village by an elongated concrete pathway (Picone, 2015). The temple floor had been raised several times to avoid the flood, as shown by the small size of the entrance crawl-doors and half-seen windows. This situation has attracted the temple to become a tourist spot both for its serious environmental threat issue and historical / cultural significance of community.

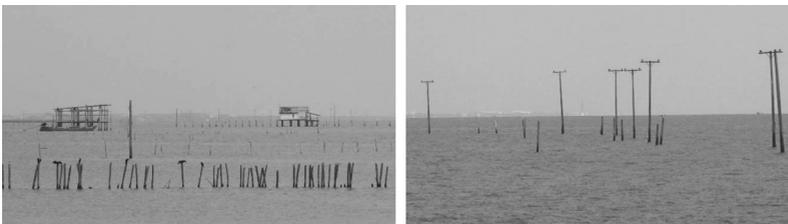
Figure 4. The remaining structures of some houses are still trapped in the distant water (left) and numerous electricity poles that once ran parallel to the shoreline, are now half visible at a great distance from the coast (right). (Source: photo by the authors)

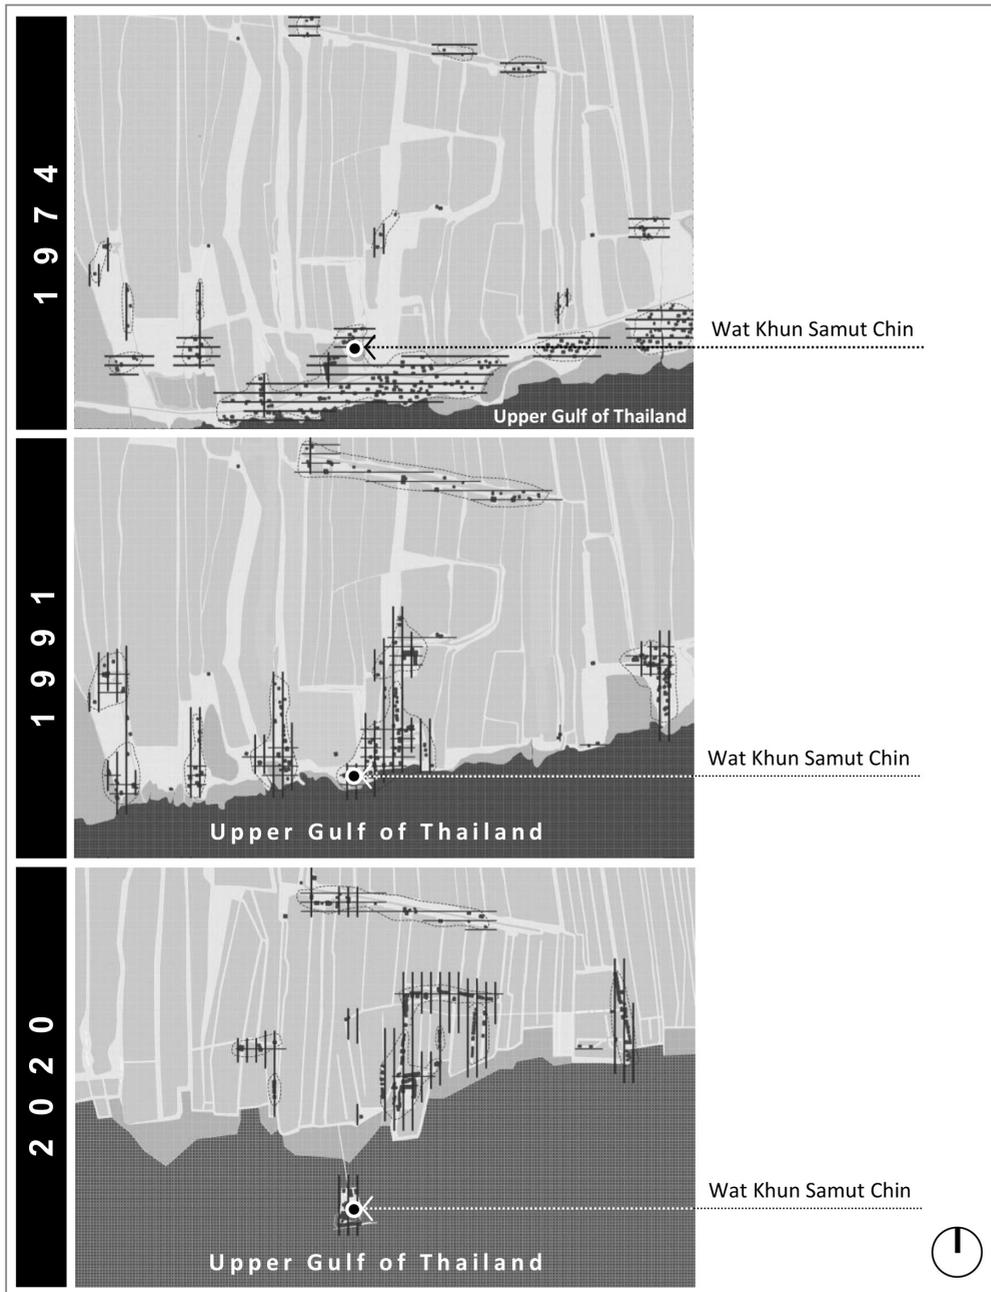
Figure 6. Figure-ground analysis diagrams of dwelling settlement pattern of Baan Khun Samut Chin in 1974 (above), 1991 (middle), and 2020 (below) has changed from the horizontal to perpendicular to the coastline. (Source: Samutprakan Office of Public Works and Town & Country Planning, modified by the authors, 2020.)

relocation driven by the coastal erosion. The community has inevitably adapted their physical environments in order to survive the problem over these years. In 1974, the settlement pattern of nearly 600-700 households (Figure 6 top) appeared to be lying horizontally along the coastline owing to its potential site for both marine trade and coastal fishing careers. Only a few houses far from the coastline had been left isolated without any utilities approach. In the past, the established main pier and the road cut through with infrastructure system was once reached to the coastline community. However, nowadays, numerous electricity poles were just visibly seen in a vast ocean.

Since the severe coastal erosion came in 1991 (Figure 6 middle), the community was hardly able to adapt and deal with it in time. Some decided to move out while the others with fishing career continued to stay till the number of households had fallen by half (300 households remain). A significant change in re-settlement was that each residential unit, that was once horizontally parallel to the coastline, was turned to be located perpendicularly to the coastline. Many buildings have been submerged under water because of the substantially decreasing coastline area. As the eroded area increased, the community was forced to move their houses to a higher ground, one a kilometre away from the coastline. Fishing career were declining and some replaced by shrimp farm, leading to a change in land allocation to a long, thin rectangular shape of shrimp farm perpendicular to the sea. In addition, the community also had problems maintaining a balance between protecting the coastal erosion by planting mangroves and taking advantage of the sea for shrimp farm allotment.

To the present, 2020 (Figure 6 below), only 110 households left in the area, indicated that the ongoing erosion of coastal land has occurred more than 1.1 kilometers. This community would be seriously considered to be in a state of collapse if the erosion problem was still continuing. The settlement has almost changed from the horizontal pattern to be the perpendicular to all coastlines. The community has been aware of the ongoing serious land erosion problem. An attempt to plant mangroves as barrier preventing coastal erosion was re-started. In the maps, it was clearly seen that, in the last 50 years, Wat Khun Samut Chin (black dot in Figure 6 maps) has been the only surviving place, the one islet in the area. This was because the community tried intently to preserve their community temple by building a long concrete footbridge connected from the eroded mainland.

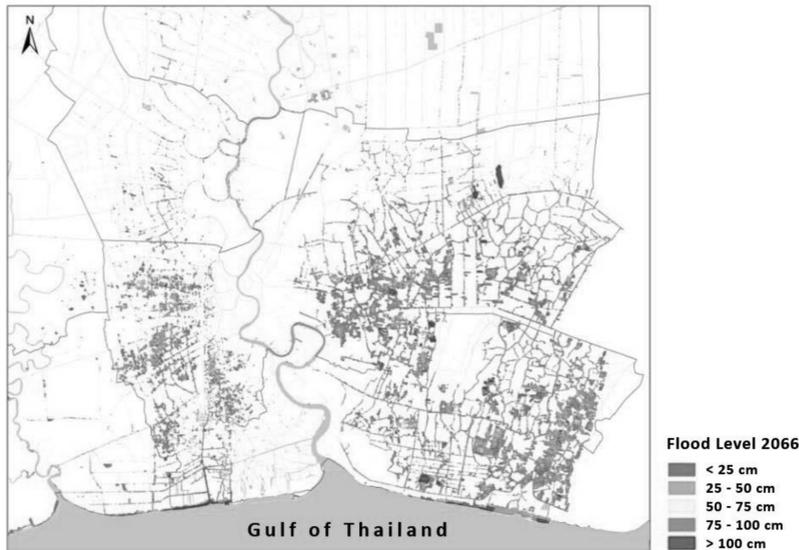
Figure 7. Map showing that the area of Ban Khun Samut Chin will have a sea level more than 1 meter in 2066. (Source: Trisirisatayawong, I. and Cheewinsiriwat, P. (2013))

Based on the report on Coastal Erosion and High Sea Level Rising due to Climate Change of Bangkok Metropolitan Administration, the sea level will rise by 1 meter in the next 30-50 years (Urban Development Planning Division of BMA, 2013), which is consistent with the Assessment Report of Flooded Area from Sea Level Rise in Upper Coastal Area of Gulf of Thailand (Trisirisatayawong and Cheewinsiriwat, 2013) (Figure 7). During a seasonal flood of this local village, the average water level will rise 1.5 meters per year coupled with 60 cm. land subsidence. Another report of Climate Change Information Center, Department of Science and Technology, Chulalongkorn University, stated that Laemphapa (local territory including Baan Khun Samut Chin) will have a sea level rise of 2 meters in the future (Kulpraneet, 2017) (Figure 8). Therefore, the predictable water level from above data (1.00 m. sea level rise + 1.50 m. coastal flood + 0.60 m. land subsidence) will lead to the formulation of a worst-case scenario for the design criteria that the prototype should be adapted for approximately 3 meters of water level rise over the next 30 years.

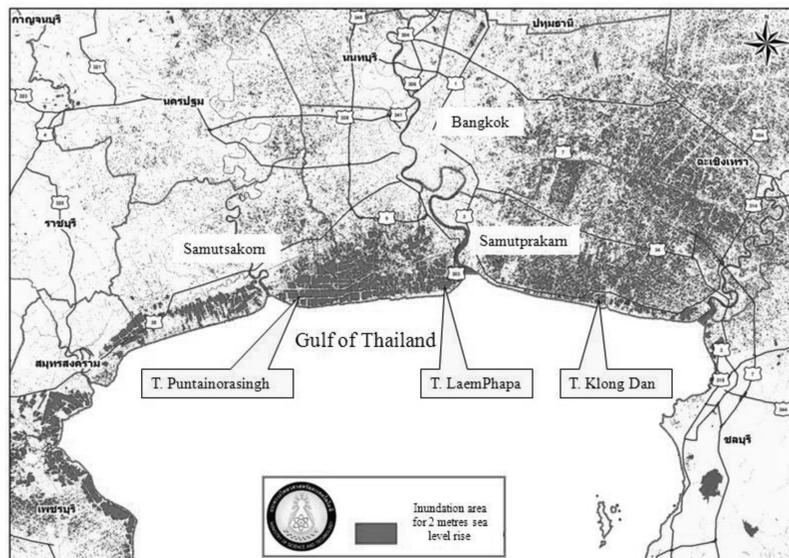
Figure 8. Inundation coastal areas in the Gulf of Thailand for the scenario of 2 meter sea level rise (Source: Climate Change Information Center, Department of Science and Technology (2009) Inundation areas of the Gulf of Thailand for scenario 2 meter sea level rise. Chulalongkorn University, Bangkok. cited in Kulpraneet, A. (2017))

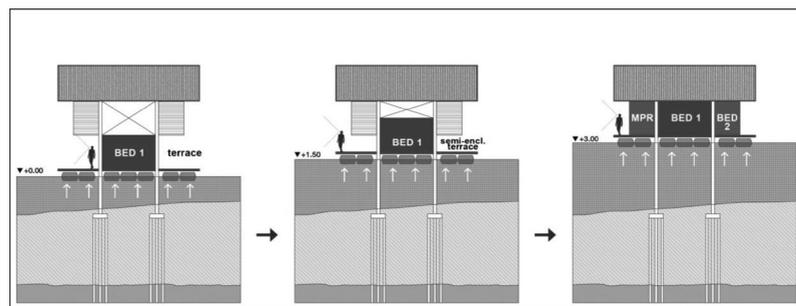
Figure 9. The conceptual idea of longitudinal section shown integrating the floating floor & walls to the fixed column supporting roof above, and how its adaptation from an outdoor terrace to be an extra bedroom when 3-meters sea level rising in the next 30 years. (Source: designed by the authors)

In addition to the perpendicular arrangement of the building to the coastline, an integration between the floating structure and the fixed structure was applied to the structural design of the building. To avoid wave energy obstruction, the less fixed foundations of building was, the more resilient ability of the building was ensured. The idea was to construct the houses in a way to allow them to float on the surface of rising sea level whereas the building’s amphibious was still connected to the ground foundations in their own lands as necessary (Figure 9). The fixed structure was applied to reduce their Dead Loads as much as possible, leading to the design that there were only four columns with deep triangular-concrete pile foundation to support only roof structure. The loading weight of buoyancy structure itself or in conjunction with any Live Loads (user’s weight, appliances, and furniture) was safely carried by the floors and walls of the house.

Resulting from the above structural design in which buoyancy and fixed column were integrated, the vertical distance between floor to roof height would allow residents for their living adaptation in the case of sea level rising for 3 meters in the next 30 years, especially on activities related with fishing career. The light weight and easily adjustable material, or possibly folded or rotated, e.g., bamboo curtain and vinyl partition, was suggested for floors and walls’ design. Additionally, if in 30-years and when the sea level was rising up to 3 meters, the family might be expanding and having need of more rooms for children, the planning design was prepared to transform an outdoor terrace to be a children bedroom by interlocking between previous hanging wall and raising floor (Figure 9 and 10). The ability to transform a usage area up toward buoyancy level changes would be suitable for fisherman lifestyle in the community under the worsen circumstance of the coastal situation.

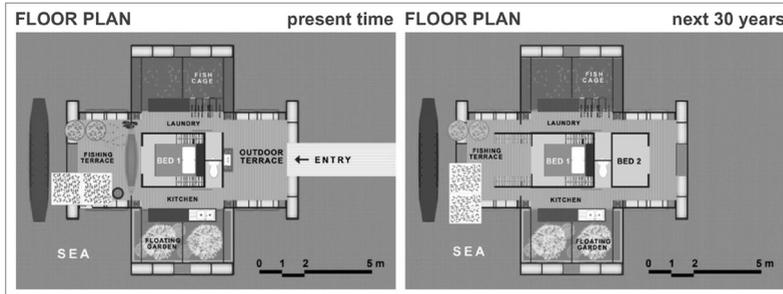
Figure 10. Floor plan of a resilient house shown adaptation from an outdoor terrace (left) to be a bedroom 2 for kid (right) when the sea level rises up to 3 meters in next 30 years (Source: designed by the authors)

The house was consisted of one storey with double-height level at present sea level. If the sea level was rising up, the outdoor terrace would be transformed to be an enclosed another bedroom. The functional utilities were for dwelling unit such as bedroom, toilet, bathing, and service corridor for kitchen and laundry, and for working space such as fishing terrace, floating basket for keeping fish in water, as well as floating vegetable garden. The calculation of the loading capacity on the prototype building was divided into 2 parts; a fixed structure with deep foundation and a floating structure with pontoons. The total load of buildings was reduced by the presence of the fixed structure, with only 4-columns and enclosed roof since triangular-concrete pile foundation acted as anchors tied to their own land. Therefore, the weighting load of the floating structure, both dead and live load, would rely on the number of PE pontoons. The calculation data of the total load (Table 1) showed that 48 tanks of 200-litres Polyethylene pontoons were required for supporting the total weight of the floating house structure at 7,688 kg (5,400 kg of live load + 2,288 kg of dead load), based on a safety factor of 1.2 in the structural stability control examination.

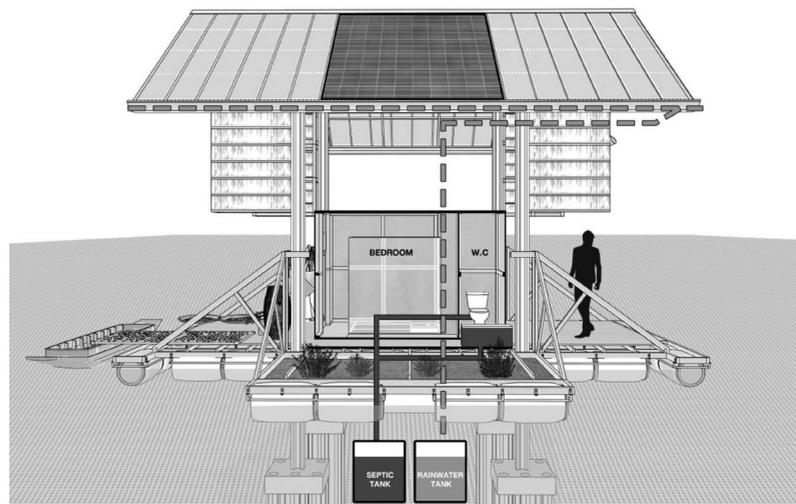
Figure 11. Perspective section of resilient house shown septic tank and rain water collecting tank underneath buoyancy platform, and solar cell on the roof (Source: designed by the authors)

In a construction planning, each space design was integrated with modular coordinating system to regular prefabrication size. For example, equally divided 1.20 x 2.40 cement board with regular 6-metres steel length was implemented and efficient for cost saving and material usage without any waste. For energy consumption, the house should be sustained by itself as much as possible. The rain-water collecting tank underneath raising platform and solar cell on the roof top were added to maintain energy consuming both sanitary and electrical system without relying on civil infrastructure. The followings were drawings of floor plan, section, and exploded axonometric of resilient house for Baan Khun Samut Chin community (Figure 10-12):

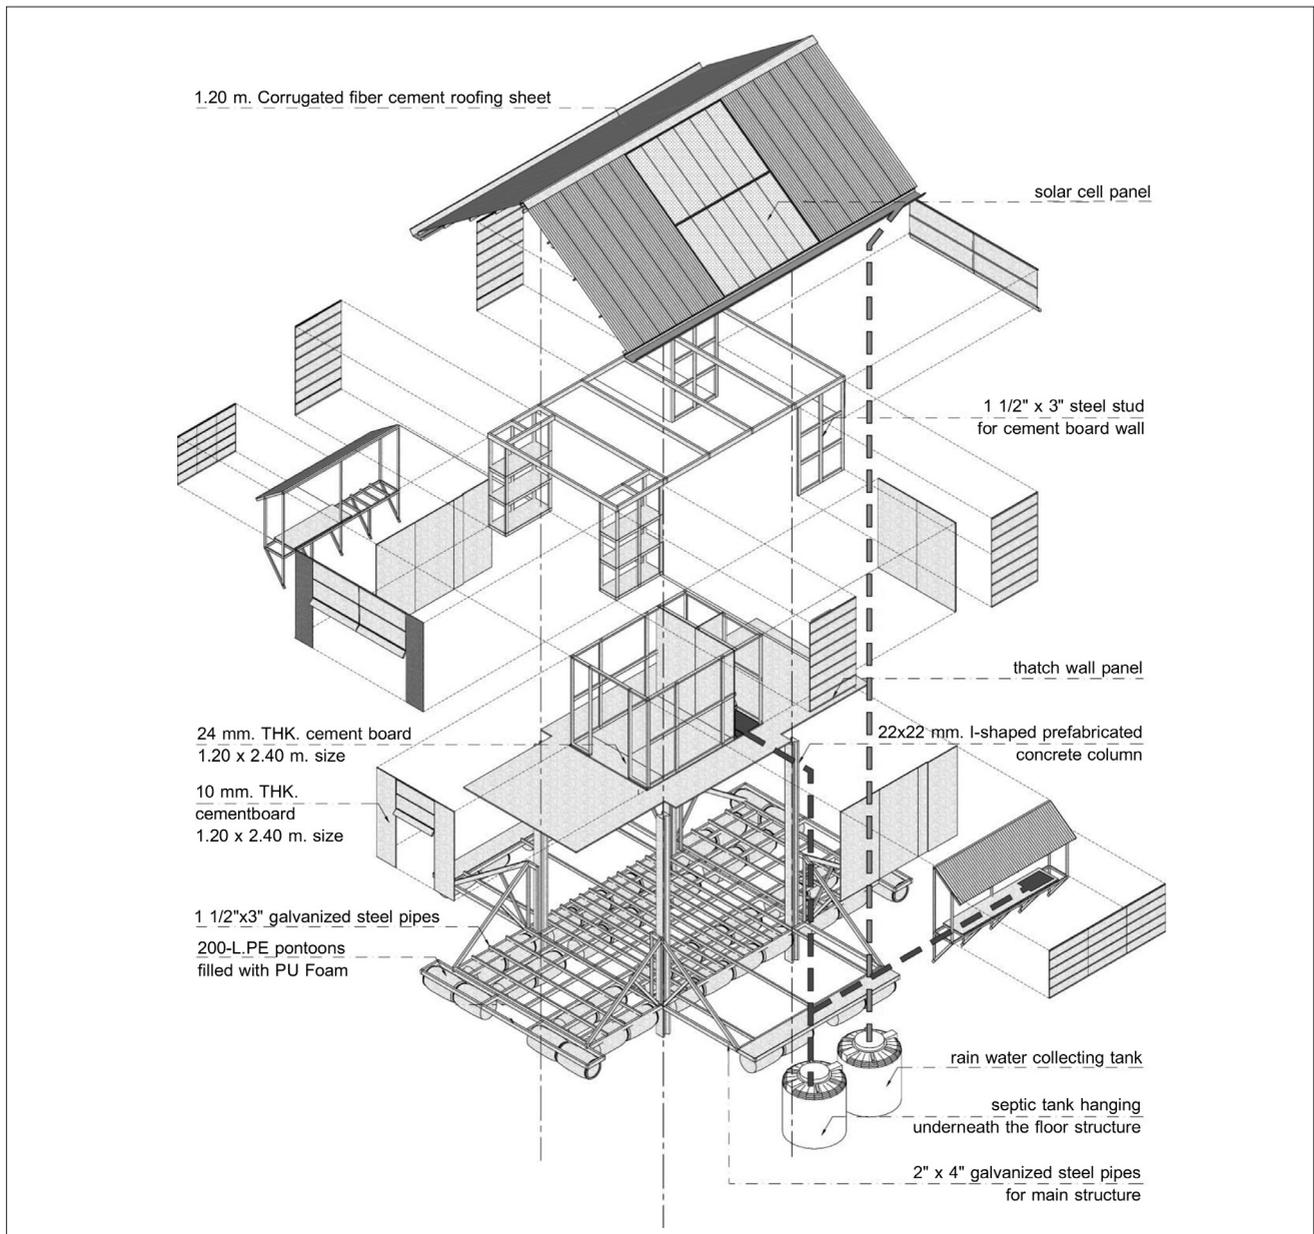
Figure 12. Exploded axonometric drawing of resilient house shown assemblage of each parts of building (Source: designed by the authors)

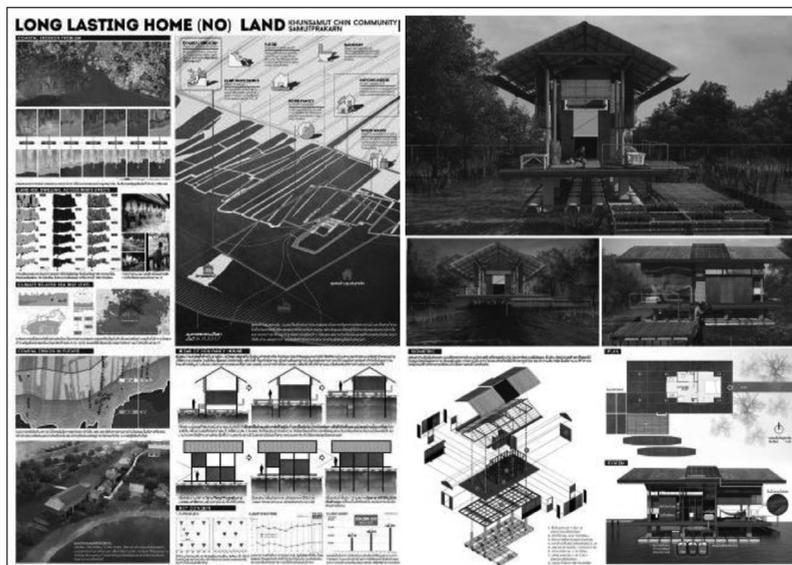
Figure 14. The presentation board of an experimental prototype house for Baan Khun Samut Chin community, submitted on the title "Long Lasting Home (no) land" in the ASA Experimental Design Competition 2020 organized by The Association of Siamese Architects under Royal Patronage. (Source: Boonlue, W. (2020))

At the end of this study, the prototype design with construction drawing package were contributed back to the community for a further implementation in the near future (Figure 13). Also this experimental prototype won the third prize award in the ASA Experimental Design Competition 2020: “The Everyday Heritage”, which was organized by The Association of Siamese Architects under Royal Patronage (ASA, 2020) (Figure 14).
