# Field Response of an Instrumented Dyke Subjected to Rainfall

**ABSTRACT:** A field study was undertaken of an instrumented dyke on soft Bangkok clay in Pathumthani, Thailand. The studied site was characterised using dynamic cone penetration tests, field vane shear tests and Spectral Analysis of Surface Waves geophysical tests. The pore-water pressure, suction, moisture content and rainfall were continuously monitored over the rainy season in 2017. The soft clay nearer the dyke had higher strength than in the zone further away due to consolidation. The upper 0.5 m of dyke fill material made up of silty and clayey soils were found to experience drastic suction changes, reaching 1800 kPa towards the end of a drought and abruptly reducing to 20–40 kPa within a day upon the onset of the rainy season. Such large and abrupt changes of the suction are likely to have aggravated the surface cracking and hence the dyke movements. In contrast, the response at 3 m depth from the dyke shoulder was almost insensitive to the short-term rainfall patterns. Vertical movement of the dyke surface showed compression-swelling phenomena, probably due to the combined effects of drying, collapse-on-wetti

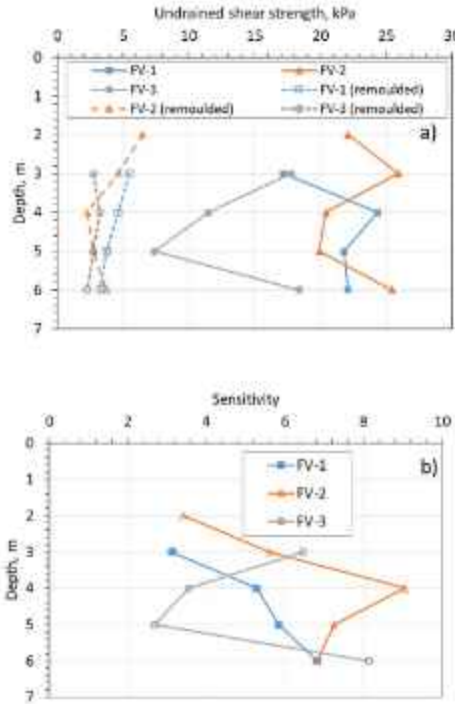
Figure 3 Field vane shear test results

A series of in situ tests were performed to characterise the ground profile on the AIT side of the dyke. Field vane shear tests at 3 locations (FV-1, FV-2 and FV-3 as shown in Figure 2) were conducted to characterise the soft clay layer from a depth of 2 m up to 7 m, beyond which the medium-to-stiff clay layer was encountered. The tests used a GEONOR H-10 device according to ASTM-D 2573-01. Variations of both peak and remoulded undrained shear strength along with the sensitivity are plotted in Figure 3. The peak undrained shear strength,  $s_u$ , for locations FV-1 and FV-2, which were near the dyke toe, followed a similar trend, being relatively constant with depth (20-25 kPa). However, the peak  $s_u$  values for location FV-3, which was 15 m outside the dyke area, was somewhat lower, ranging between 7 and 17 kPa. The FV-3 shear strength likely represents the strength of original ground, before dyke construction. The clay nearer the dyke toe (FV-1 and FV-2) would have consolidated as a result of dyke fill after the original dyke was built about 50 years ago, and the additional fill was placed in 2012. The clay near the dyke is therefore of higher peak strength. The remoulded strength was of similar value for all locations, indicating similar intrinsic properties. The thickness of the soft clay is only about 4-5 m at this site. The clay is classified as moderately-sensitive to sensitive, and of similar sensitivity value for all three locations, ranging from 3 to 9. This trend is in a good agreement with previous studies on Bangkok clay (e.g. Horpibulsuk et al., 2007; Mairang & Amonkul, 2010).

The estimated undrained shear strength is about 27 kPa which is slightly higher than what was measured by field vane shear test. However, it is worthwhile to note that the field vane shear test was carried out at the dyke toe while the SASW was performed at the crest. Therefore the soft clay tested by field vane shear test would have experienced lower overburden pressure comparing to the soft clay tested by SASW test which has experienced higher overburden pressure due to the weight of the dyke.

While it is true the penetration resistance and the stiffness should show a good correlation, and hence similar profiles, the compatibility between the KPT blow count profile (Figure 4) and shear wave velocity profile (Figure 7) cannot be strictly discussed due to inherent difference in the test principles, resolution and range of measurement of the two tests. The KPT was conducted on a small amount of soil (a local measurement), while the SASW test was on a much larger amount of soil (a global measurement) and showed the averaged shear wave velocity of the soil mass. The KPT result presents a profile over 3.6 m at a 0.2 m resolution, while the SASW result extends down to 16m depth but at a resolution of 1-4 m. In addition, the KPT resistance at a depth greater than 1.5 m is likely be affected by the skin friction along the rod in the soft clay above that depth, as discussed earlier. Hence the results of KPT and SASW tests were not considered contradictory, if not in clear agreement. More importantly, the SASW tests indicated the presence of compacted dyke fill, the crust and a similar thickness of soft clay as determined from the field vane shear tests.

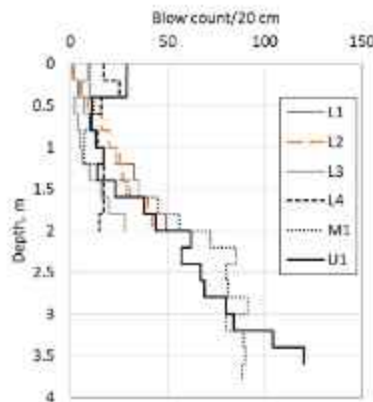
Figure 4 Kunzelstab Penetration test (KPT) results

The crust zone of the Bangkok clay is a weathered medium-stiff to a stiff clay. This crust layer, as well as the dyke fill have been characterised by means of light-weight dynamic cone penetration test, or so-called Kunzelstab Penetration test (KPT). This test involves dropping a 10 kg weight, with a falling height of 0.5 m, on a 60° cone with a diameter of 25 mm connected to 20 mm diameter rod. The number of blow counts was recorded for each 20 cm of penetration. The KPT has been carried out at six locations (K-U1, K-M1, K-L1, K-L2, K-L3, and K-L4 as shown in Figure 2) on the AIT side of the dyke. Figure 4 shows the plots of blow counts versus depth for all locations. The blow count number appeared to be fairly constant up to 1.5 m depth below which it started to increase linearly with depth. Notably, the KPT resistance (blow count number) below 1.5 m depth was likely affected by the skin friction in the soft clay along the rod above that depth. The presence of soft clay was confirmed by the SASW results, presented in the following section.

Thus, the blow count number appeared to increase with depth, indicating a larger accumulated skin friction along the depth in the soft clay. Nevertheless, the upper crust zone from zero to 1 m depth appeared softer nearer the dyke (L1 and L2) than outside (L3 and L4), likely due to ground depression near the toe (Figure 2). The lower crust zone from 1 to 2 m depth at Location L4, outside of Dyke area, appeared softer (lesser blow count) than crust beneath the dyke.

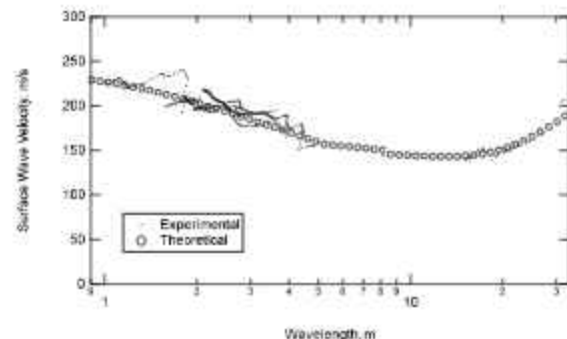
Figure 6 Experimental and theoretical dispersion curves of AIT dyke

Spectral Analysis of Surface Waves (SASW) testing, the technique developed by the University of Texas at Austin (Nazarian et al., 1983, Stokoe et al., 1994), was performed at the crest of the dyke in order to measure the shear wave velocity of the dyke and the soil foundation. The test was performed using a sledgehammer and a 300-kg drop weight as a seismic source for shallow and deep profile investigations, respectively. The receivers were two 2-Hz geophones manufactured by Geospace. The arrangements of the source and receivers were the Common Receiver Midpoint geometry for short spacing (1, 2 and 5 m) and the Common Source geometry for long spacing (10 and 20 m), due to the difficulty in relocating the drop weight. The results from these spacings were combined to determine the shear wave velocity profile using WinSASW program, also developed by the University of Texas at Austin (Joh, 1996). The combined experimental and theoretical dispersion curves are shown in Figure 6. The shear wave velocity profile, evaluated from iterative forward modelling analysis, of the site is shown in Figure 7. Soil properties are also shown in Table 2.

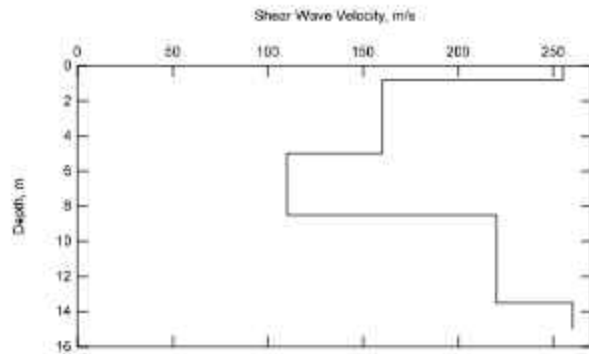
Figure 7 Shear Wave Velocity Profile measured from AIT Dyke

The result indicates the shear wave velocity of 160-255 m/s in the first 5m representing the embankment and the top crust materials. It, then, drops down to 110 m/s for the next 3.5m representing the thickness of soft Bangkok clay. After that the velocity becomes higher than 220 m/s representing much stiffer soils. The undrained shear strength of the soft soil was estimated using Equation 1 developed by Ashford et al. (1996) where  $v_s$  = shear wave velocity (in m/s) and  $s_u$  is an undrained shear strength (in kN/m<sup>2</sup>).

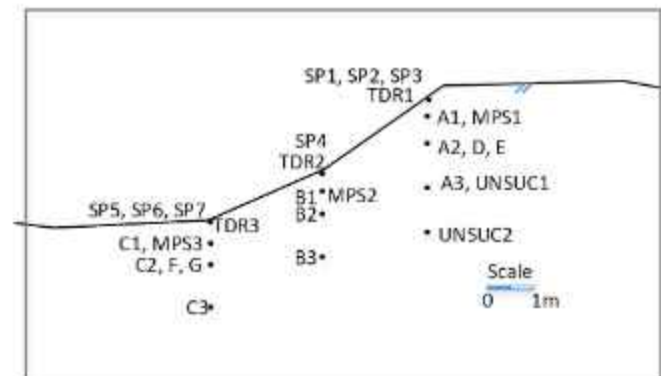
Figure 8 Location of instruments and survey points

The instruments installed at the site are shown in Figure 8, including 13 tensiometers (Kasetsart University or KU-type), 2 flushable tensiometers (UNSU), 3 MPS suction sensors, 3 Time Domain Reflectometry moisture sensors (TDR), 1 tipping bucket rain gauge, and 1 interval camera. Settlement plates have been installed on the slope at 7 locations (SP1 to SP7). The details of these instruments regarding installation depth and location are summarized in Table 3.

The KU-tensiometers were installed at various locations (A1, A2, A3, B1, B2, B3, C1, C2, C3, D, E, F, and G) from depths of 0.5 to 2 m along the slope as shown in Figure 8. The installation procedure of KU tensiometers is described in Figure 9. First, a hole was created by hand auger and pipe driving to the required depth. Afterwards, a PVC casing was inserted down the hole. The tensiometer was then inserted into the PVC casing and a good contact between the tensiometer's ceramic tip and the soil was ensured by checking response by a gentle push in the field. A thin layer of clay paste was also applied to the ceramic tip to improve contact condition. Any gap between the tube and drilled hole was backfilled with cement-bentonite-kaolin grout. It was always ensured that the tensiometer was well saturated with water and no air bubble was present in the reservoir by checking suction reading before installation. After some time during the monitoring period, if the reading suggested that the suction could be higher than 80 kPa and the air-bubble may form inside water reservoir, the KU-tensiometer would then be removed from the borehole through the PVC tube, up to the ground, for checking and re-filling with water later.

These tensiometers were flushed whenever cavitation was detected as indicated by the suction readings. The frequency of tensiometer maintenance depends on the location and the depth of installation. For example, UNSUC tensiometers were flushed twice during the rainy season when suction reading suggested cavitation had occurred. During the prolonged dry season, re-saturation of the tensiometer was not attempted, since the tensiometer always cavitated after re-saturation due to the ground's high suction. The other type of device, Decagon MPS6 (Figure 11a) works on a different principle and has a much wider measurable range of suction. They measure the electrical capacitance of the ceramics that is in direct contact with the soil and hence changes its retained water volume in equilibrium with the soil's suction. Inevitably, this principle implies that the suction measurements are subject to the hysteresis of the ceramics' water retensivity. Three MPS6 were installed at 0.5 m depth, each of which at the shoulder, middle and toe of the slope (Figure 8).

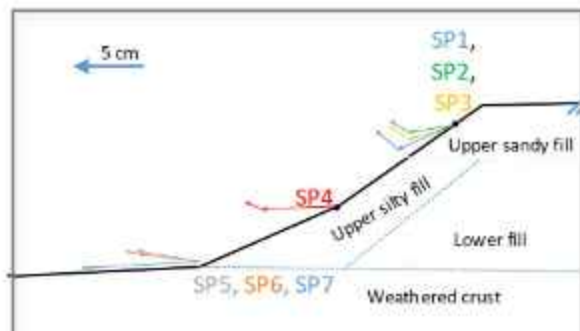
Figure 19 Dyke surface movement

Surface movement of the dyke was monitored by means of Total Station surveying. Two permanent benchmarks were constructed on the piers of nearby bridge which were assumed to be stationary. These benchmarks were used as reference points for the Total Station device. The measured coordinates (x, y, z) of all the settlement points (SP1 to SP7) were then used to calculate the vertical and horizontal movements as shown in Figure 19.

The Total Station surveys were made on 18 April, 9 May, and 27 July 2017. The vectors of the surface movement were calculated based on the initial conditions on 18 April 2017. Therefore, the first increment of the vector represented the movement that was caused by the first period of rain which took place between the end of dry season and the first week of May. The toe surface showed some heaving of less than 0.5 cm while the crest of dyke appeared to settle by about 0.5 to 1.5 cm. The middle part of the dyke experienced negligible settlement. Since the first measurement period (from 18 April to 9 May 2017) involved both drying and wetting, the first settlement could be related to both desiccation compression as well as collapse-on-wetting phenomena.

The second vector increments of movement, however, show that nearly all settlement points along the dyke swelled by about 0.5 to 1 cm during the wetting period from 9<sup>th</sup> May until 27<sup>th</sup> July. It is noteworthy that the horizontal movements were constantly outwards and their magnitude appeared to be considerable, ranging from 3 to 6 cm. This magnitude of movement seemed excessive and perhaps be affected by the accuracy of horizontal movement from the Total Station survey itself. The first increments of Vectors SP1, SP2 and

SP3 nevertheless appeared to be downwards at an angle similar to the boundary between upper and lower fills. The movement at the toe (SP5, SP6 and SP7) also seemed to be mainly horizontal. Although not conclusive, this trend seems to indicate that the movement may primarily take place in the upper fill. This upper fill was also the zone of smaller shear resistance and where pore-water pressure changed to the greater extent. However, the surface movement could also be attributed to the creeping movement of the soft clay foundation soil, though this cannot be fully proven at the moment. The photographs at different periods from the interval camera (Figure 20) did not show a clear sign of exacerbating longitudinal crack along the crest. Yetable 1t, it was quite difficult to confirm the movement based on the interval camera photo alone since the vegetation became thicker during the rainy season. All in all, the movement of the dyke appeared to be related to the change in pore-water pressure and likely be related to the upper part of fill that was recently placed.
