Settlement of River Dykes and Their Adjacent Residences on Soft Clay Deposits After the Tohoku-Pacific Ocean Earthquake in 2011

K. Yasuhara¹, S. S. Yang², I. Horikawa² and H. Yamane²

ABSTRACT: Among the extensive infrastructure collapses which resulted from the cataclysmic earthquake that struck off the eastern coast of Japan on March 11, 2011, long-term settlement and deformation of clay deposits during the earthquakes has sometimes been overlooked. This paper describes a case history of post-earthquake settlement of clay deposits underlying river dykes and their adjacent residences. Particularly, an attempt is made to assess reactive countermeasures designed to mitigate damage from such settlement and deformation.

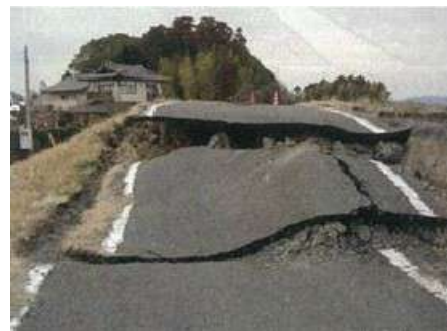
(a) River dyke failure

Photo 1 Damage features after the earthquake

Damage to the river dyke and the sluice pipe was remediated soon after the earthquake. However, damage to residences including

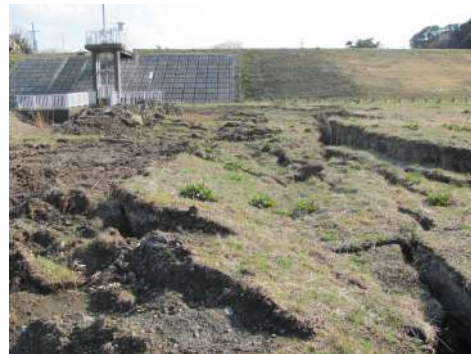
(b) Damage to the sluice pipe

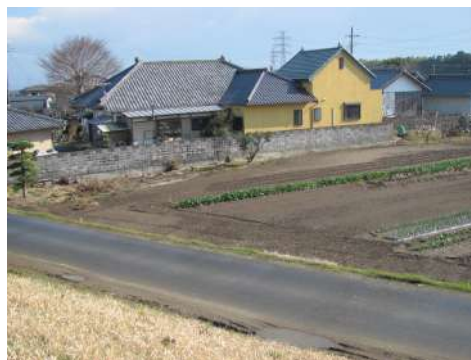
(c) Damage to the residence outer wall

cracks in the exterior walls was recovered completely or was left for discussion among residents and the government because it was not certain which factors were responsible for increasing damage to residences, although settlement and inclination had been observed since the start of river dyke construction, as explained later in this paper. In any case, long-term settlement and deformation are expected to result from existence of the thick clay layer underlying the sand layer, having the soil profile shown in Figure 2.

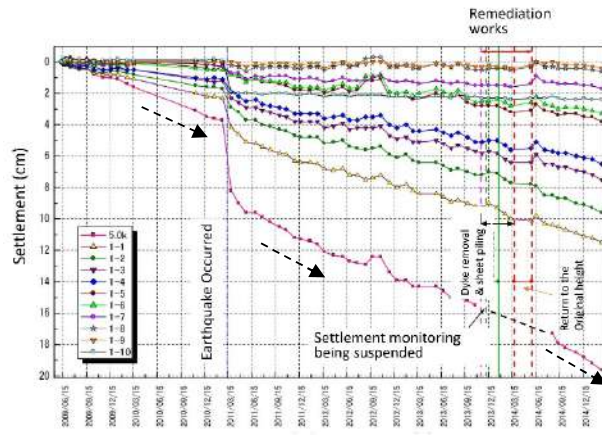
Figure 5 Settlement vs. time curves for river dykes

A set of typical observed settlement vs. time relations for river dykes and residences continuously before and after the earthquake is presented in Figures 5 and 6. It is noteworthy that settlement took place and influenced the adjacent residences probably because of a

lack of installation of countermeasures having been undertaken along the river dykes. The figures also show that the earthquake occurrence in 2011 accelerated the settlement of river dykes and residences.

As might be readily apparent from the results depicted in Figure 5 and Figure 6, the following behavior was observed after installing the countermeasures stated above.

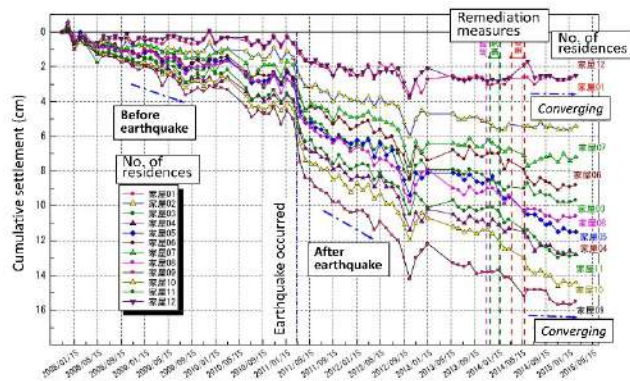
Figure 6 Settlement vs. time curves for residences.

- Settlement of residences accumulated up to 14 cm for the prior six years starting in 2007.

- Settlement increased to around 2 cm immediately after the earthquake in 2011.

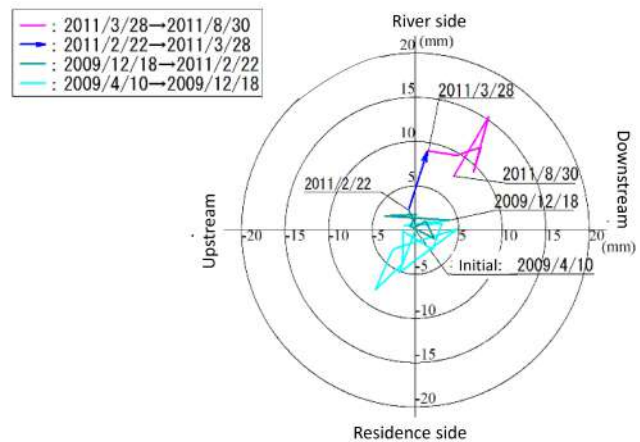
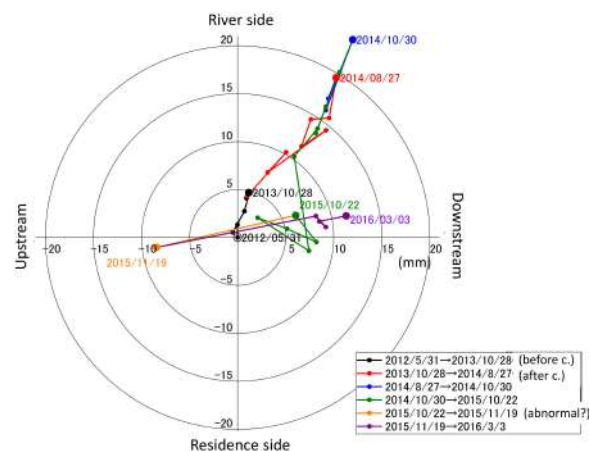
Figure 7 Measurement results of lateral displacement.

Borehole inclinometer installation at river dyke toes and borehole inclinometer measurements were conducted respectively from April 2009 to August 2011 and from May 2012 to March 2016. The monitored results presented in Figure 7 indicated the following.

- Inclination at the toes of dykes increased in the direction of residences before the earthquake. It tends to return to the dyke after the influence of the earthquake.
- Inclination tends to increase again towards the residences after the countermeasure execution but its magnitude is not so severe to influence on the residences.

(a) April 2009 – August 2011

(b) May 2012 – March 2013

Judging from the tendencies presented above, information of inclination monitored at the toe of dykes proves the effectiveness of the countermeasures adopted to avoid earthquake influences.

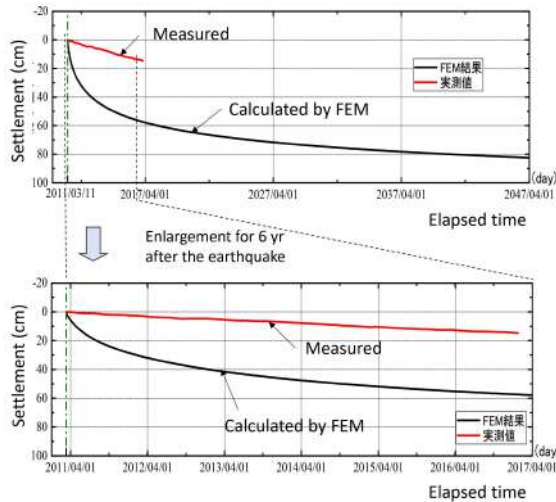
Figure 16 Calculated and measured settlement variations over time

Calculated settlement at the slope shoulder of the rear river is shown in Figure 16 for comparison with those measured. Figure 16 (a) demonstrates the following.

- The predicted total settlement of river dykes will be greater than 90 cm for the next 30 yr.
- Settlement must persist for more than 30 yr. In addition, Figure 15 (b) expanding the settlement vs. time relation during the 6 months after the earthquake indicates that the calculated settlement reaches 57.4 cm in 6 months after the earthquake, which is approximately four times the measured one as 14.8 cm.

According to comparison of calculated variations of settlement with elapsed time with the measured one as shown in Figure 16, there is no good agreement with both. Here, parameters related to long-term settlement of Ac2 clay were re-determined using back analysis to adapt to the measured variations of settlement with time. The result calculated using the modified values of two parameters in the following way is shown in Figure 19.
