# Reclamation Project of a Brownfield Site at Rio de Janeiro State, Brazil

**ABSTRACT:** The paper presents the geotechnical solution proposed for remediation and further redevelopment of a Brownfield site from a bankrupted zinc processing industry. All installations were abandoned without a post closure technical plan, including a 1.2 million cubic meters mineral waste pile inside a 260,000 m<sup>2</sup> liquid waste pond. Both structures were settled upon a soft clay deposit contaminated with Zn and Cd. The technical solution proposed involved the complete drainage of the liquid pond, accompanied by on site treatment, a hydraulic barrier of pump & treat wells and the construction of an engineered waste containment facility using the mineral solid waste as compacted earth fill material combined to geosynthetic products.

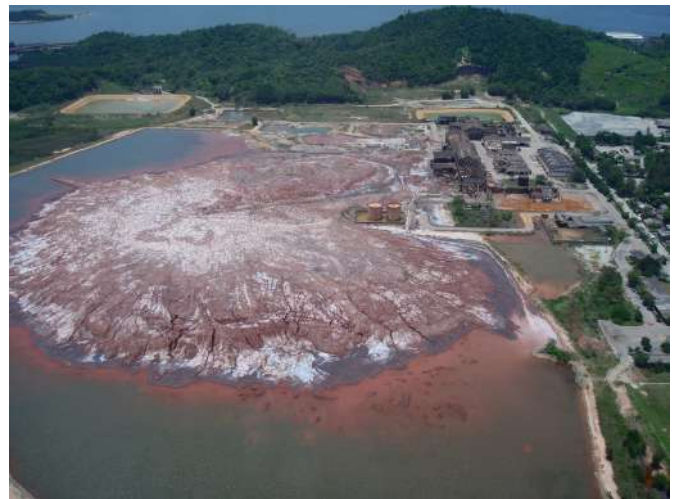
Figure 1 Aerial photograph on November 23<sup>rd</sup> 2007 (Courtesy by José Araruna Tavares Jr.)

Figure 1 is an aerial view of the site at the time of the study, with the waste pile and the liquid waste pond (identified as C-130 when the industry was in operation), and showing Sepetiba Bay water at the upper side of the image.

To the right there is an elevation with a granite quarry that is still active. To the left there is mangrove vegetation covering both margins of a meandering river towards the bay, named as Saco do Engenho.
