Field Measurements on Piled Rafts with Grid-Form Deep Mixing Walls on Soft Ground

Kiyoshi Yamashita¹, Junji Hamada² and Takeshi Yamada²

ABSTRACT: Piled raft foundations have been used for many buildings including tall buildings in excess of 150 m in height in Japan, since a piled raft was first used to the four-story building in 1987. This paper offers recent two case histories for an advanced type of piled rafts. The piled rafts combined with grid-form deep cement mixing walls were employed for a seven-story building and a twelve-story building to cope with liquefiable loose sand as well as to reduce consolidation settlements of soft cohesive soil below the loose sand. The high-modulus grid-form soil-cement walls confine the liquefiable loose sand so as not to cause excessive shear deformation to the loose sand during earthquakes. To confirm the foundation design, field measurements were performed on the foundation settlements and load sharing between raft and piles from the beginning of construction to 72 and 27 months after the end of construction for the former and the latter buildings.

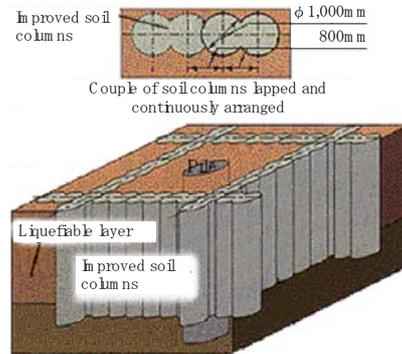
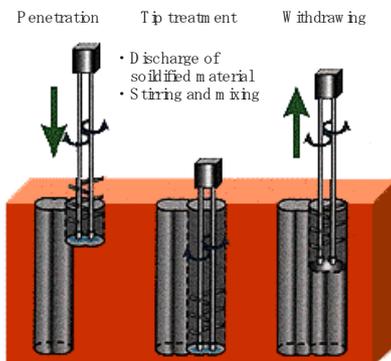
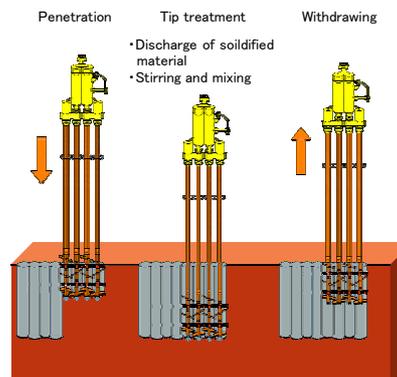
Figure 1 Grid-form deep cement mixing walls

Figure 1 shows grid-form deep cement mixing walls constructed by deep mixing method (TOFT method). The high-modulus soil-cement walls confine loose sand so as not to cause excessive shear deformation to the loose sand during earthquakes. The nominal compressive strength of the soil cement is typically 2 N/mm².

(a) Grid-form soil-cement walls

(b) Construction procedure (2-axle type)

(c) Construction procedure (4-axle type)

An assessment of a potential of liquefaction during earthquakes was carried and it indicated that the loose silty sand between depths of 3 m to 7 m below the ground surface had a potential of liquefaction. The foundation level was at a depth of 4.8 m, so that the grid-form deep cement mixing walls were introduced to cope with the liquefiable soil below the raft. The grid-form soil-cement walls were constructed using the recently developed 4-axle machine shown in Fig. 1 (c) to reduce the construction period.

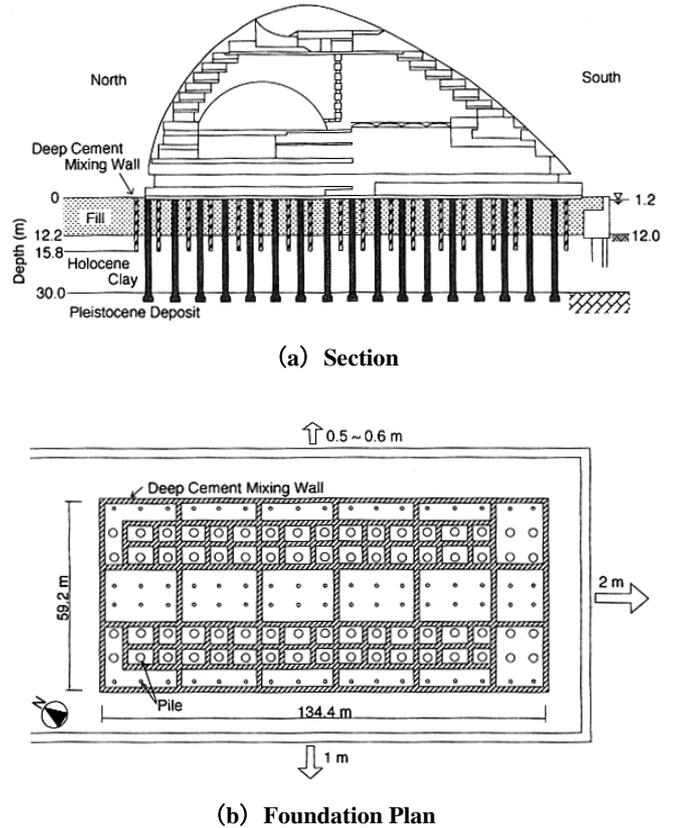
The TOFT method was developed late in the 1980s and the effectiveness of the method was highlighted during the 1995 Hyogoken-Nambu earthquake. Figure 2 shows a 14-story building constructed on the pier that faces the Port of Kobe. The building was supported on cast-in-place concrete piles surrounded by the deep cement mixing walls. During the 1995 Hyogoken-Nambu earthquake, the quay walls on the west, south and east of the building moved horizontally by 1 m, 2 m and 0.5 to 0.6 m, respectively. Nevertheless, the building survived without damage to its pile foundations (Tokimatsu et al., 1996).

Figure 2 Building founded on piles surrounded by Deep Cement Mixing wall (Tokimatsu et al., 1996)

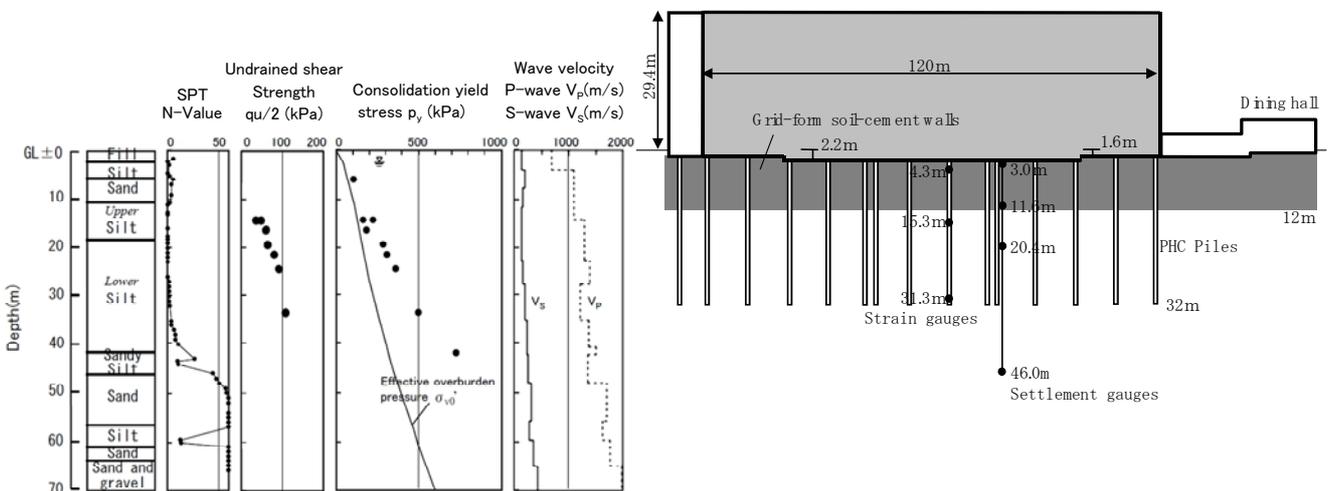
Figure 3 Schematic view of the building and foundation with soil profile

The seven-story office building of 29.4 m in height above the ground surface with a flat dining hall is located in Minamisuna, Tokyo (Photo 1). The building is a steel-frame structure and a schematic view of the building and foundation with soil profile is shown in Fig. 3. The ground water table appears approximately 2 m below the ground surface. The subsoil consists of an alluvial stratum to a depth of 46 m, underlain by a diluvial sandy layer of SPT *N*-values of 50 or higher. The soil profile down to a depth of 11 m is made of soft silt and loose sand. Between depths of 11 m to 42 m below the ground surface, there lies a thick soft to medium silt stratum. The upper silt layer between depths of 11 m to 18 m is slightly overconsolidated with an overconsolidation ratio (OCR) of about 1.1. The lower silt layer between depths of 18 m to 42 m is overconsolidated with an OCR of 1.8 or higher.

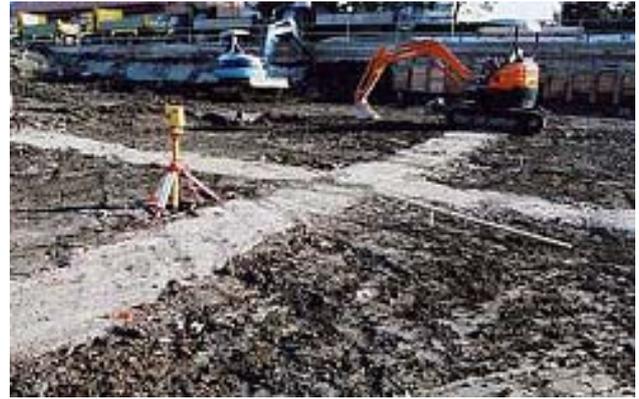
Photo 2 Grid-form soil-cement walls at the foundation level

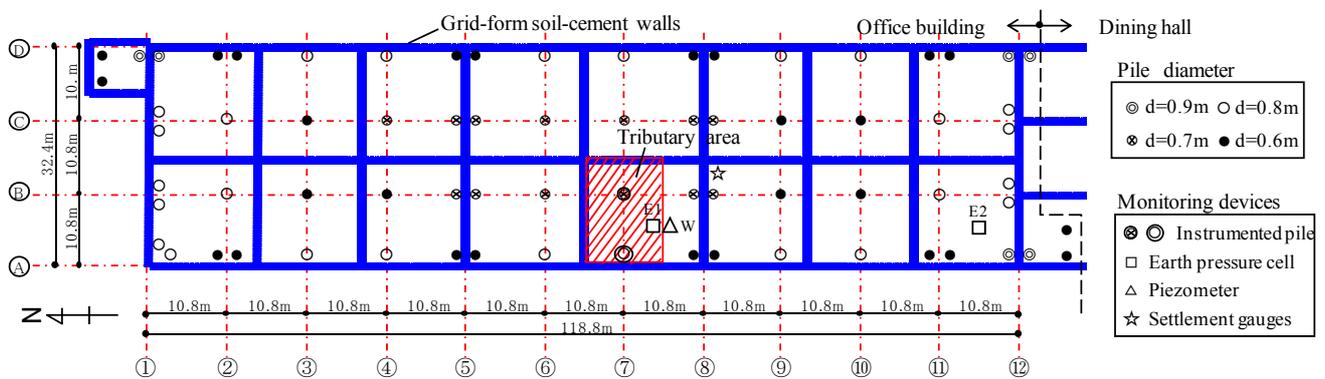
Figure 4 Layout of piles and grid-form soil-cement walls with locations of monitoring devices

into a pre-augered borehole filled with mixed-in-place soil cement to avoid noise and vibration. Figure 4 shows a layout of the piles and the grid-form soil-cement walls.

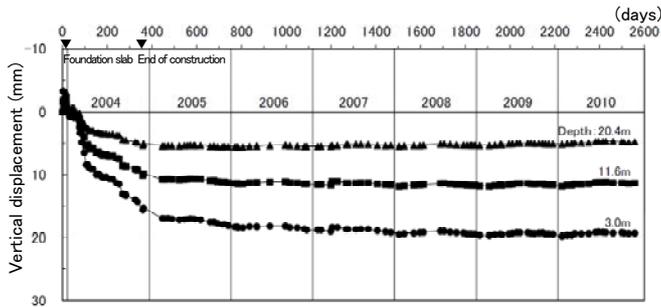
Figure 5 Measured vertical ground displacements

Figure 5 shows the measured vertical ground displacements below the raft at depths of 3.0 m, 11.6 m and 20.4 m relative to a reference point at a depth of 46 m from the ground surface. The ground displacement at the depth of 3.0 m amounted to 15.6 mm at the end of construction. After that the displacement slightly increased and reached 19.3 mm at 72 months after the end of construction.

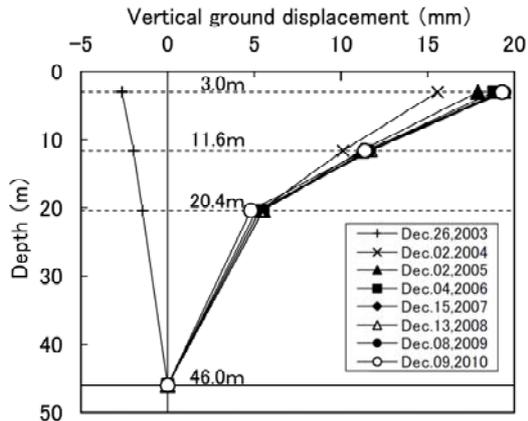
Figure 6 Measured vertical ground displacements with

Figure 6 shows the distributions of the measured vertical ground displacements with depth. Heaving of the ground due to the excavation amounted to 2.6 mm at a depth of 3.0 m just before casting of the foundation slab (26th Dec., 2003). Including the heaving, the vertical ground displacement at a depth of 3.0 m was 18.2 mm at the end of construction and reached 21.9 mm at 72 months after the end of construction. Figure 7 shows the longitudinal settlement profile of the raft measured by an optical level. The measured settlements were 14 to 24 mm at the end of construction. The settlements slightly increased to 17 to 31 mm at about four years after the end of construction (13th Dec., 2008) and the maximum angular rotation of the raft was 1/1200 radian between the columns 11B and 12B. The measured maximum settlement of the raft and the measured maximum angular rotation were in good agreement with the predicted values.

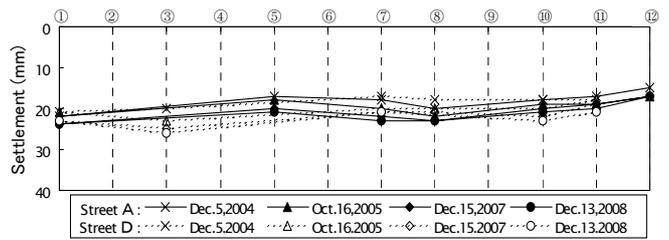
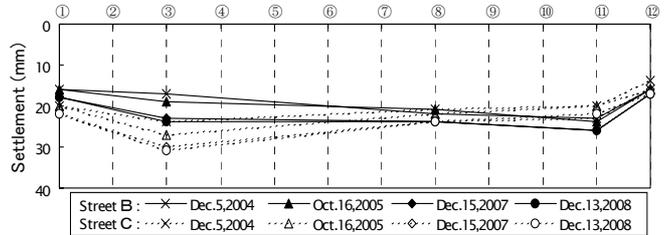
Figure 7 Measured longitudinal settlement profiles

(a) Alignments A and D

(b) Alignments B and C

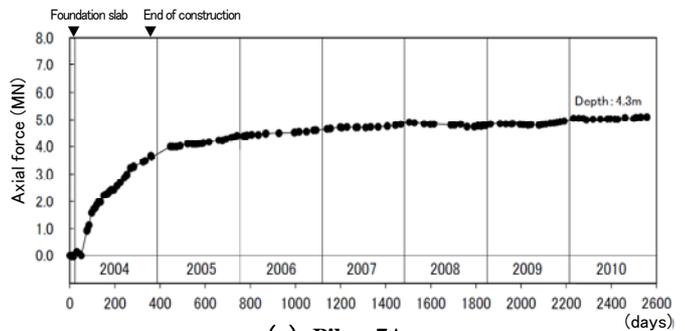
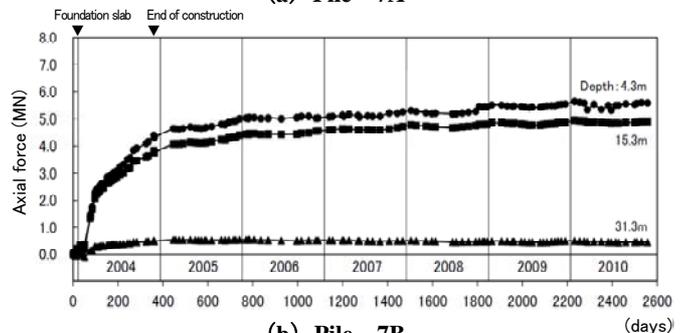
Figure 8 Measured axial loads of piles 7A and 7B

Figure 8 shows the measured axial loads of the piles 7A and 7B. The measured loads at pile head increased after the end of construction, and reached a state of equilibrium for both piles at about four years after the end of construction. Figure 9 shows the distributions of the measured axial loads on the pile 7B. At the end of construction, the average skin friction between depths of 15.3 m to 31.3 m through the layers of soft to medium silt was 90 kPa whereas the value between depths of 4.3 m to 15.3 m through the layers of soft silt and loose sand was 23 kPa. The average skin friction in the lower part of the pile is consistent with the average undrained shear strength of the silt (81 kPa) between depths of 15.3 m to 31.3 m. After that the

(a) Pile 7A

(b) Pile 7B

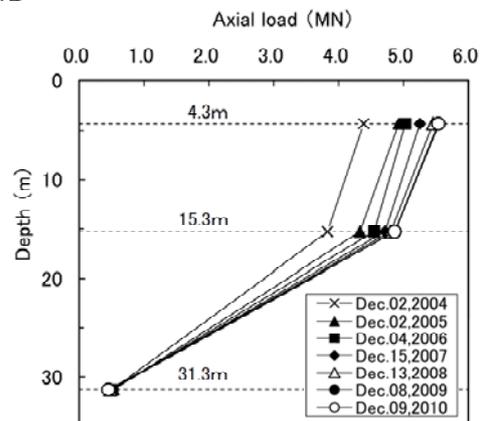
Figure 9 Measured axial load distribution on pile 7B

skin friction in the lower part considerably increased to 127 kPa at 72 months after the end of construction, which is 1.6 times as large as the average undrained shear strength. The skin friction in the upper part slightly increased after the end of construction. Figure 10 shows development of the measured contact pressures of the raft and pore-water pressure beneath the raft. The contact pressures seemed to reach constant values in early stage of construction despite of the successive loading due to construction.

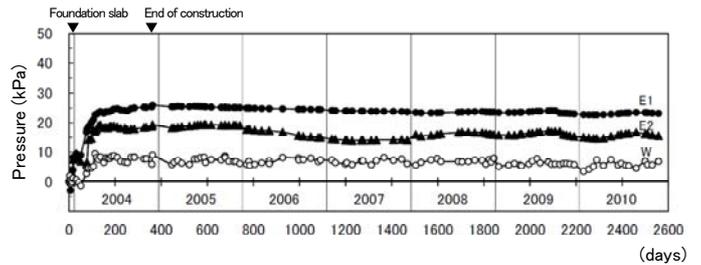
Figure 10 Measured earth pressures and pore-water pressure

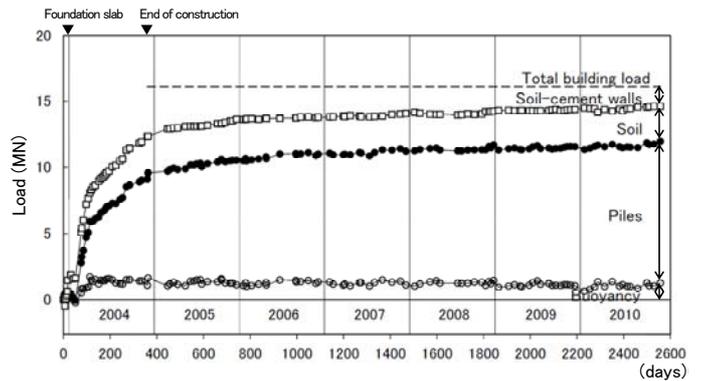
Figure 11 shows the time-dependent load sharing among the piles, soil, the soil-cement walls and the buoyancy on the tributary area. Assuming that the total load on the tributary area, W_t , given by Eq. (1) is equal to the sum of the design column load on the tributary area, the load sharing between raft and piles can be estimated by Eqs. (2) to (4). Table 2 shows the load-sharing ratios to the effective load on the tributary area at the end of construction and those at 72 months after the end of construction. The ratio of the load carried by the piles to the effective load was estimated to be 0.54 at the end of construction. Thereafter, the ratio of the load carried by the piles gradually increased to 0.72 at the end of observation. On the other hand the ratio of the effective load carried by the grid-form soil-cement walls to the effective load considerably decreased after the end of construction while the ratio of the effective load carried by the soil slightly decreased after the end of construction. As for the raft-soil-pile interaction behaviour on the above, the possible mechanism was as follows:

Figure 11 Time-dependent load sharing between raft and piles

- Small amount of consolidation settlement occurred in the normally consolidated silt layer below the raft to a depth of 6 m due to loading in excess of the effective overburden pressure of the silt.
- The excessive load transferred to the soil-cement walls and this caused consolidation settlement in the upper silt layer with an OCR of about 1.1 just below the base of the soil-cement walls.
- Consequently a part of the load carried by the soil-cement walls gradually transferred to the piles.

Meanwhile the ratio of the load carried by the piles to the total load was estimated to be 0.50 at the end of construction and 0.66 at the end of observation. The ratio of the load carried by the piles to

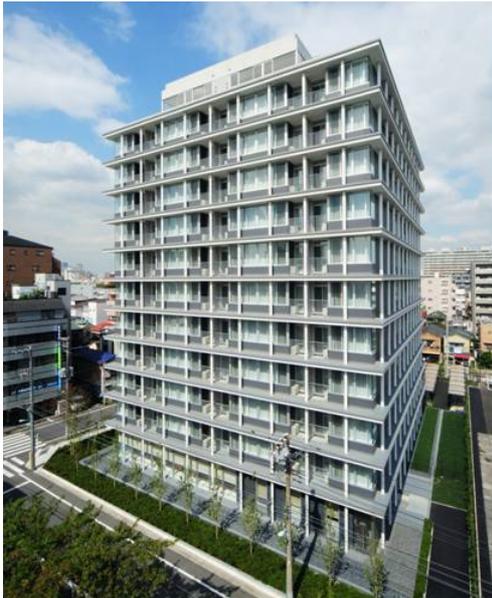
Photo 3 Twelve-story building in Toyo

The twelve-story residential building of 38.7 m in height above the ground surface is located in Toyo (Photo 3), at a distance of 0.7 km west from the seven-story building. The building is a reinforced concrete structure with base isolation system of laminated rubber bearings (Photo 4). Figure 12 shows a schematic view of the building and foundation with a typical soil profile. The subsoil consists of an alluvial stratum to a depth of 44 m, underlain by a diluvial sand-and-gravel layer of SPT *N*-values of 60 or higher. The ground water table appears approximately 1.8 m below the ground surface. The soil profile down to a depth of 7 m is made of fill, soft silt and loose silty sand. Between depths of 7 m to 44 m, there lie very-soft to medium silty clay strata. The upper silty clay between depths of 7 m to 15.5 m is slightly overconsolidated with an overconsolidation ratio (OCR) of about 1.5. The lower silty clay between depths of 15.5 m to 44 m is overconsolidated with an OCR of 2.0 or higher.

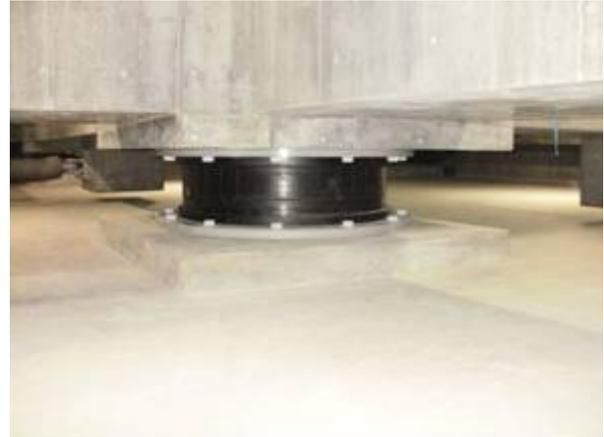
Photo 4 Laminated rubber bearings

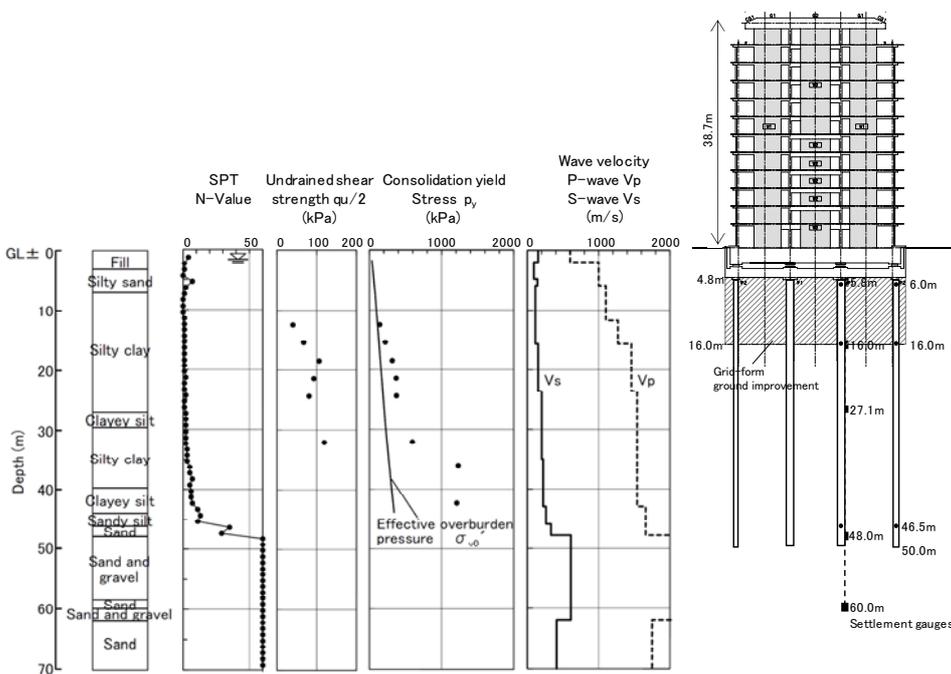
Figure 12 Schematic view of the building and foundation with soil profile

Field measurements were performed on the foundation settlement, axial loads of the piles and contact pressures between raft and soil as well as pore-water pressure beneath the raft from the beginning of construction to 27 months after the end of construction. The locations of the monitoring devices are shown in Fig. 13. Two piles, 5B and 7B, were provided with a couple of LVDT-type strain gauges at depths of 6.0 m (pile head), 16.0 m and 46.5 m (pile toe) from the ground surface (Photo 5). The pile was constructed by inserting four precast piles (one 12-m long SC pile and two 12-m long and one 9-m long PHC piles) into a pre-augered borehole filled with mixed-in-place soil cement (Photo 6). Near the instrumented piles, eight earth pressure cells and one piezometer were installed beneath the raft at a depth of 4.8 m. The six earth pressure cells E1 to E6 were installed on the intact soil, and the two earth pressure cells D1 to D2 were installed on top of the grid-form soil cement walls. The vertical ground displacements below the raft were measured by differential settlement gauges. LVDT-type transducers were installed beneath the raft at depths of 5.8 m, 16.0 m, 27.1 m and 48.0 m to measure the relative displacements to a reference point at a depth of 60 m as shown in Fig. 12. The settlements of the

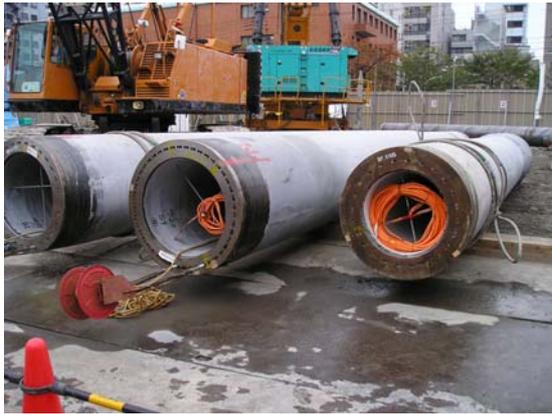
Photo 5 Instrumented PHC piles

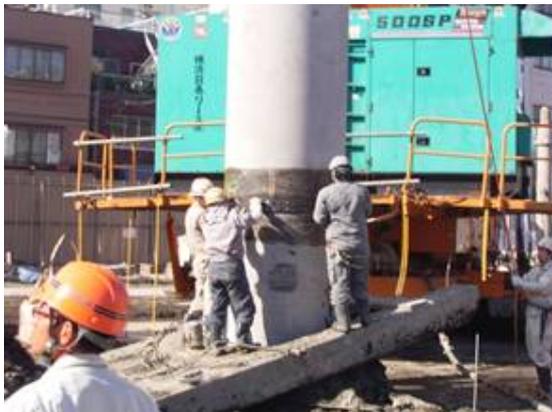
Photo 6 Construction of PHC piles (1.2m in diameter)

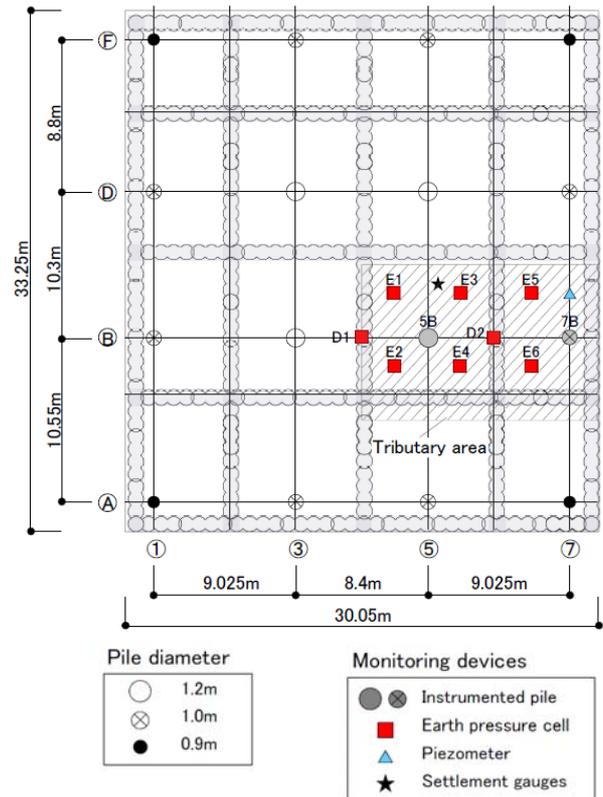
Figure 13 Layout of piles and grid-form soil-cement walls with locations of monitoring devices

Numerical analysis was carried out to obtain the foundation settlement and load sharing between raft and piles by means of the simplified method of analysis. The maximum settlement and the maximum angular rotation of the raft were predicted to be 23 mm and 1/1500 radian, respectively, which satisfied the design requirements. The ratio of the load carried by the piles to the total load was set to 0.65 in the design. The pile consisted of a steel pipe-concrete composite (SC) pile used in top portion and PHC piles. Figure 13 shows a layout of the piles and the grid-form soil-cement walls.

columns 5B and 7B shown in Fig. 13. The sum of the measured pile-head loads and raft load on the tributary area after the end of construction was 35.4 to 38.4 MN. The raft load means the load carried by the soil and soil-cement walls and was obtained by use of the contact pressures measured by the earth pressure cells E1 to E6 and D1 to D2. The sum of the measured pile-head loads and raft load on the tributary area is found to be consistent with the sum of the design load of the columns 5B and 7B of 36.0 MN.

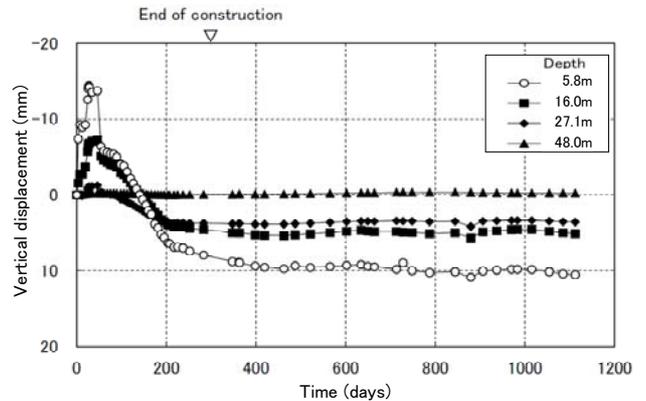
Figure 14 Measured vertical ground displacements

Figure 14 shows the measured vertical ground displacements below the raft at depths of 5.8 m, 16.0 m, 27.1 m and 48.0 m. At a depth of 5.8 m, the maximum ground heaving due to the excavation was 14.3 mm, and then, immediate settlement of 7.3 mm occurred due to casting of the 1.5 m thick foundation slab. Figure 15 shows the measured ground displacements at a depth of 5.8 m initialised just before the beginning of reinforcement for the foundation slab with those initialised just after the immediate settlement. As the immediate settlement was mostly caused by the self-weight of unset concrete of the raft directly transferred to the soil, the ground displacement initialised just after the immediate settlement is approximately equal to the settlement of ‘piled raft’. The settlement of the piled raft reached 14.3 mm at the end of construction and thereafter slightly increased to 16.9 mm at 27 months after the end of construction. Figure 16 shows the settlement profiles of the raft measured by an optical level at 22 months after the end of construction. The measured settlements were 9 to 17 mm and the maximum angular rotation of the raft was 1/1580 radian. The measured maximum angular rotation of the raft was in good agreement with the predicted one while the measured maximum settlement of the raft was slightly less than the predicted one.

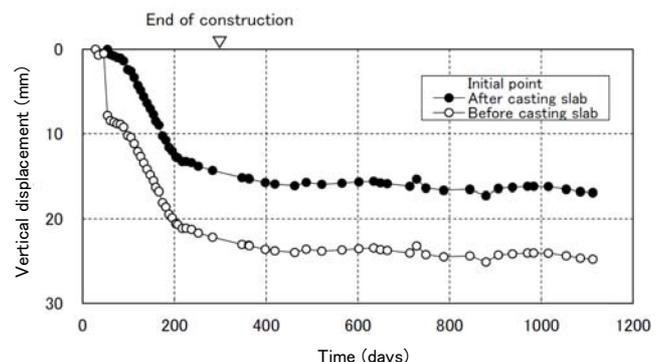
Figure 15 Foundation settlement

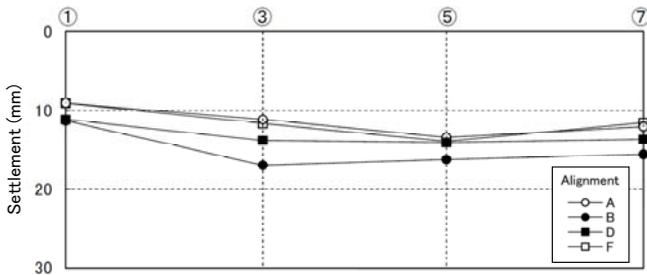
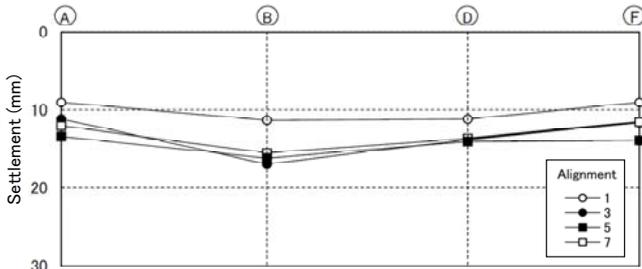
Figure 16 Measured settlement profile (at 22 months after E.O.C.)

(a) Alignments A, B, D and F

(b) Alignments 1, 3, 5 and 7

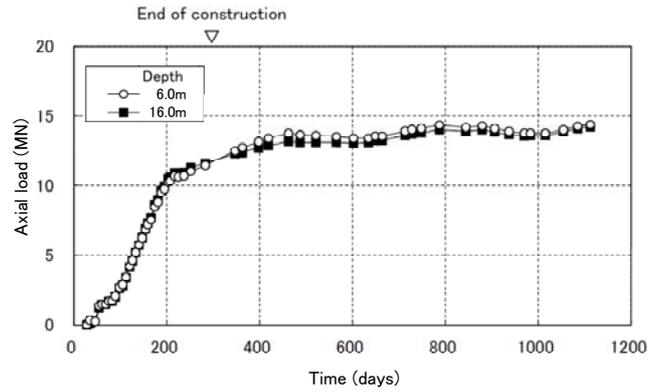
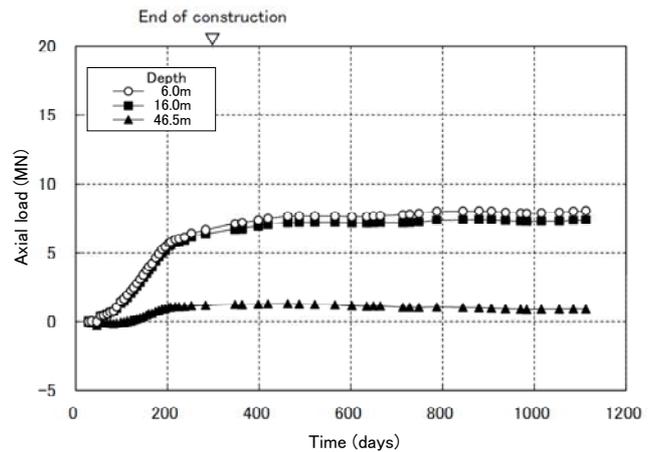
Figure 17 Measured axial loads of piles 5B and 7B

Figure 17 shows the development of the measured axial loads of the piles 5B and 7B. At the end of construction, the pile-head loads

(a) Pile 5B

(b) Pile 7B

reached 11.5 MN and 6.7 MN on the piles 5B and 7B, respectively. Thereafter, the pile-head loads for both piles slightly increased and reached 14.4 MN and 8.1 MN on the piles 5B and 7B, respectively, at 27 months after the end of construction. Figure 18 shows the distribution of the measured axial loads on the pile 7B. The average skin friction between depths of 6.0 m and 16.0 m was quite small, 9 kPa at the end of construction and 22 kPa at 27 months after the end

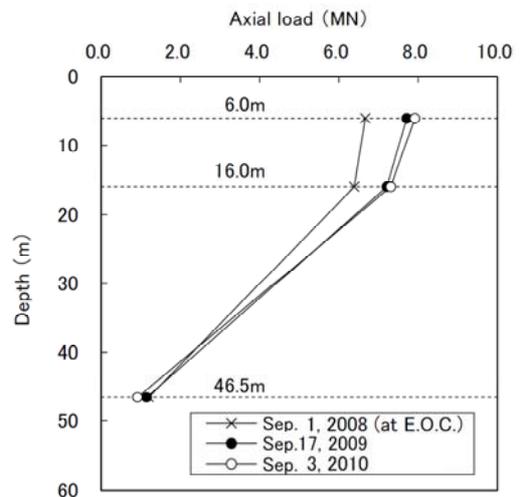
Figure 18 Measured axial load distribution on pile

of construction, whereas the average skin friction between depths of 16.0 m and 46.5 m was 54 kPa at the end of construction and 67 kPa at 27 months after the end of construction. The load transferred to the pile toe was relatively small, i.e. the ratio of the pile-toe load to the pile-head load was 0.18 at the end of construction and 0.12 at 27 months after the end of construction. Unfortunately no data were obtained at pile toe of the pile 5B due to disconnection.

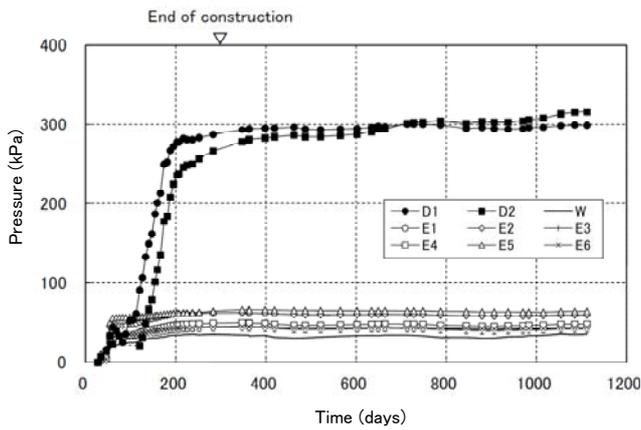
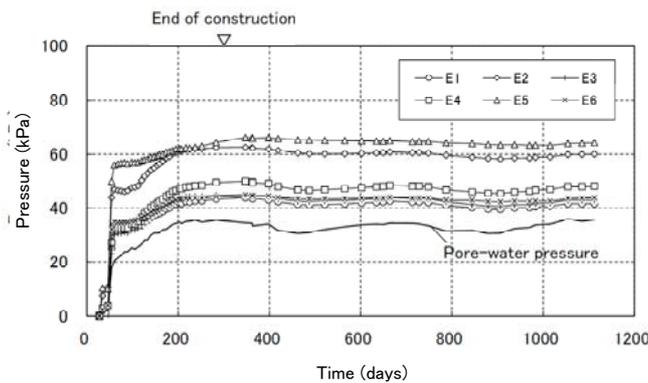
Figure 19 Measured contact pressures and pore-water pressure

(a) Contact pressures between raft and soil-cement walls and those between raft and soil

(b) Contact pressures between raft and soil

Figure 19 shows the development of the measured contact pressures between raft and soil and pore-water pressure beneath the raft. The measured contact pressures between raft and top of the soil-cement walls D1 to D2 increased with construction loading in the same way as the pile-head loads shown in Fig. 17. On the other hand, the measured contact pressures between raft and soil E1 to E6 seemed to reach a state of equilibrium in early stage of construction despite of the successive increase in construction loading. At the end of construction, the measured contact pressures were 266 to 287 kPa from the earth pressures cells D1 and D2, whereas the contact pressures were 43 to 64 kPa from the earth pressure cells E1 to E6. At 27 months after the end of construction, the measured contact pressures between raft and top of the soil-cement walls reached 294 to 304 kPa, which correspond to about six times as large as the measured contact pressures between raft and the intact soil. The contact pressures on the improved soil were quite stable after the end of construction. The measured pore-water pressure was 31 to 35 kPa after the end of construction, which was consistent with the ground water table found by the soil investigation.

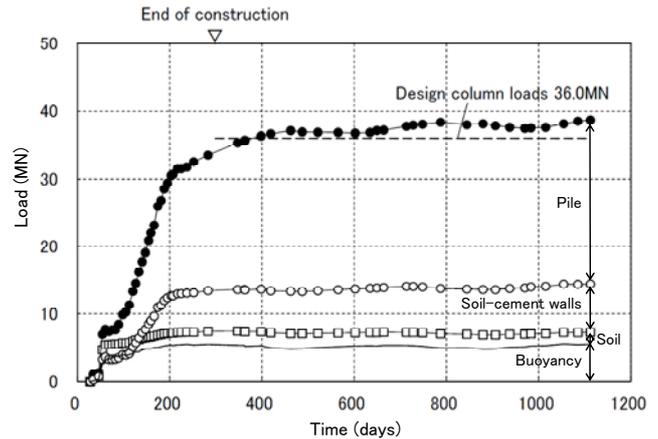
Figure 20 shows the time-dependent load sharing among the piles, soil, soil-cement walls and the buoyancy on the tributary area of the

Figure 20 Time-dependent load sharing between raft and piles

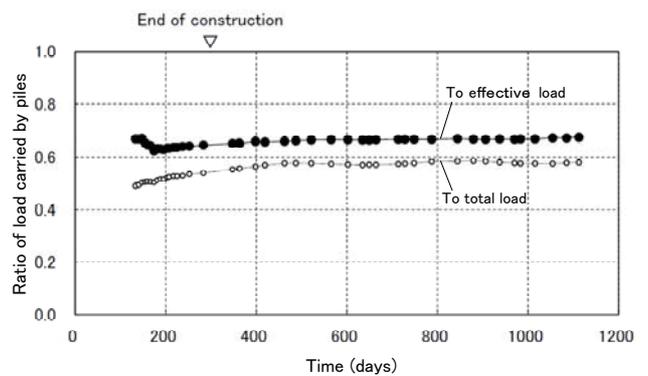
Figure 21 Ratios of load carried by the pile to effective load and total load on the tributary area

Figure 21 shows the ratio of the load carried by the piles to the effective load and that to the total load on the tributary area versus time. Table 3 shows the load sharing between raft and piles. The ratio of the load carried by the piles to the effective load on the tributary area given by Eq. (2) was 0.65 at the end of construction and thereafter slightly increased to 0.68 at 27 months after the end of construction. The ratio of the effective load carried by the grid-form soil-cement walls to the effective load on the tributary area given by Eq. (4) was 0.27 whereas the ratio of the effective load

carried by the intact soil given by Eq. (3) was 0.05 at 27 months after the end of construction. Meanwhile the ratio of the load carried by the piles to the total load on the tributary area was 0.54 at the end of construction and reached 0.58 at 27 months after the end of construction. The ratio of the load carried by the piles to the total load estimated from the measurements was consistent with the design assumption. Based on the measurement results, it was confirmed that the grid-form soil-cement walls carried the raft load successfully.
