## Advance in Geogrid Reinforced Slopes in Malaysia

T.A. Ooi<sup>1\*</sup> and C.H. Tee<sup>2</sup>

**ABSTRACT:** Geogrid product was formally introduced into and developed in Malaysia after Pilecon Holdings Sdn Bhd signed a distributorship agreement with Netlon Ltd (now Tensar International Ltd) United Kingdom in 1985. Prior to that Star Art Sdn Bhd was the distributor of Netlon product in Malaysia. Ooi & Tee (2004) examines the various case histories of slope repair and the role of geosynthetic reinforcement used in slope reconstruction and their performances for the last twenty years since the introduction of geogrids to Malaysia. Slope failure is not uncommon in many parts of Malaysia. Asahari (2009) reported more than 100 landslide incidences a year in Malaysia at a seminar on safe hill-site development in Kuala Lumpur. The frequency of occurrence of slope failure increases during the monsoon seasons where incessant rain extended over long period of time caused the slope to fail despite the fact that it may be stable for a long time. The infiltration of rainwater causes the reduction of soil suction, rise in water table and reduction of the shear strength of soil. In the cas

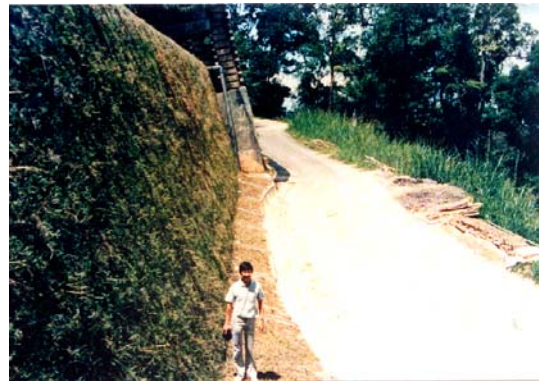
Figure 2e Petronas bungalow slope rehabilitation, 1987  
K.Y. Yong shown in the picture visited the site

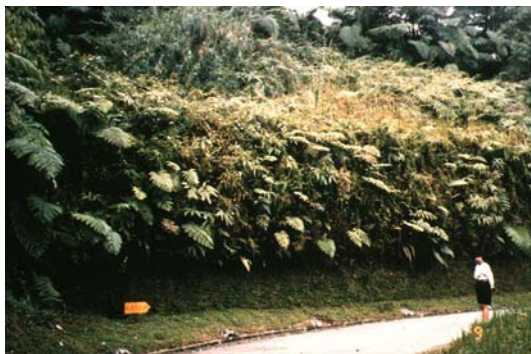
Figure 2f View of Petronas bungalow slope in 1989  
by courtesy of Mike Dobie

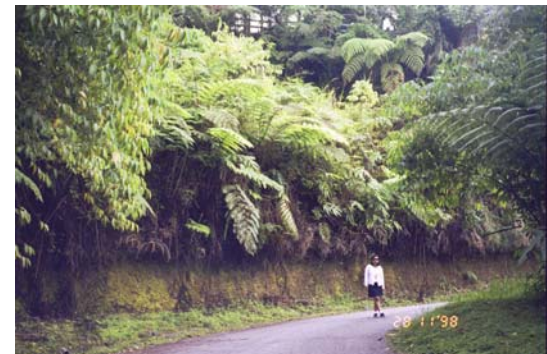
Figure 2g View of Petronas bungalow slope in 1998  
by courtesy of Mike Dobie

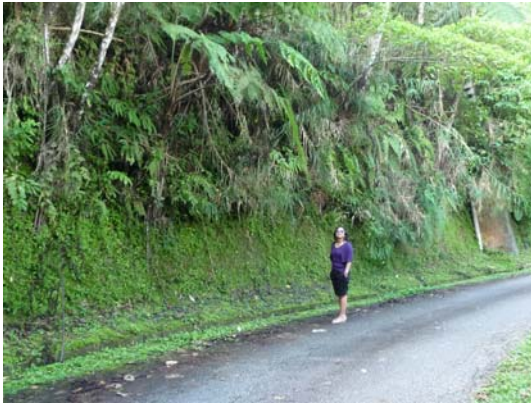
Figure 2h View of Petronas bungalow slope in 2010  
by courtesy of Mike Dobie

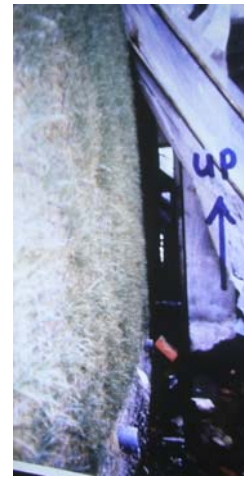
Figure 13c Wall with turfing

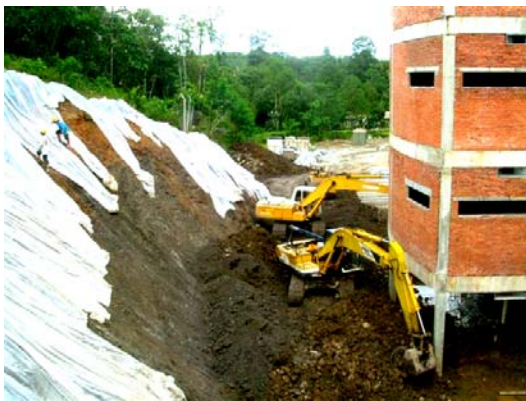
Figure 16c Removal of debris and cutting back of slope

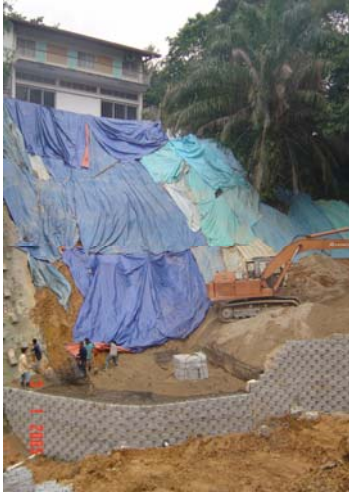
Figure 17d Construction of Modular Block wall with geogrid.

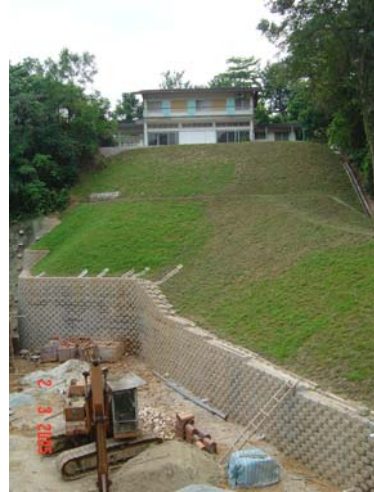
Figure 17e Picture of rehabilitated slope.

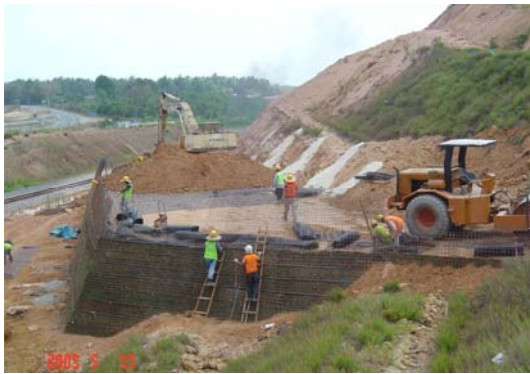
Figure 18d Construction of geogrid block on stabilized base

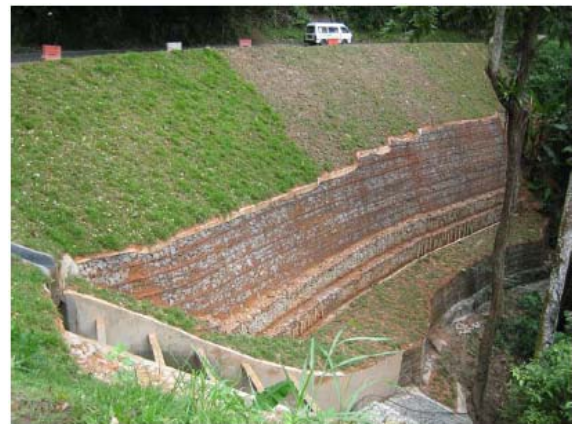
Figure 19d view of slope on rehabilitation

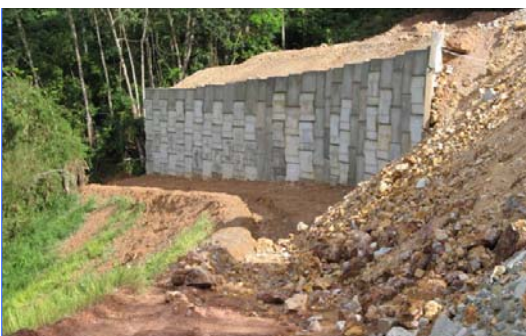
Figure 20b Anchored soil wall completed on 21<sup>st</sup> May 2006

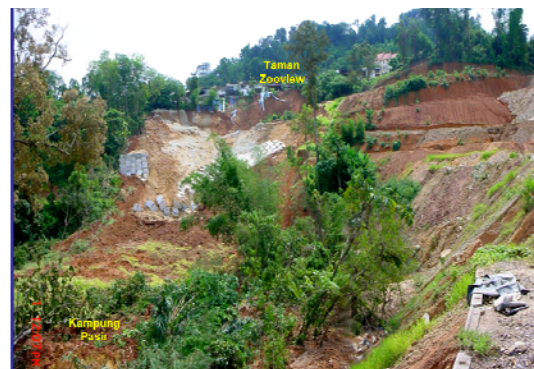
Figure 20d shows the collapse of the anchored reinforced soil wall 10 days after completion during the May 2006 monsoon season. Figure 20e shows a distant view of the landslide area covered in plastic sheets. Figure 20f shows the condition of the slope behind the plastic sheets. Figure 20g shows the schematic of rehabilitation of failed slope. Figure 20h and 20i show the respective picture of lower rock fill and upper geogrid embankment. Figure 20j and 20k shows the earthworks at formation level of the backyard. Figure 20l shows the spacious back garden. Figure 20m shows the devastated condition of the back yard before rehabilitation. Figure 20n shows the rehabilitated slope on completion. Figure 20p shows the rehabilitated slope with turf established.

Figure 20d Collapse of anchored soil wall 31<sup>st</sup> May 2006

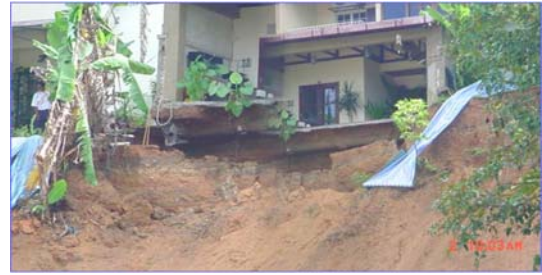
Figure 20f View behind the plastic sheets

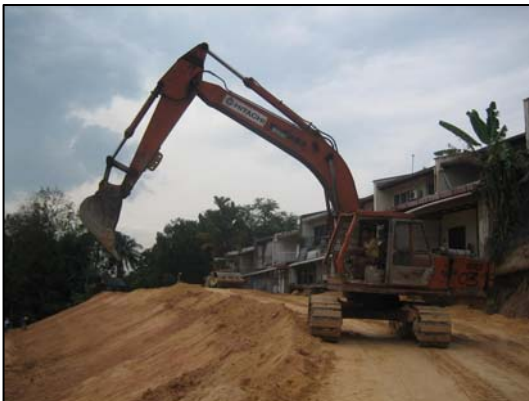
Figure 20j View of earthwork reaching the top at the backyard.

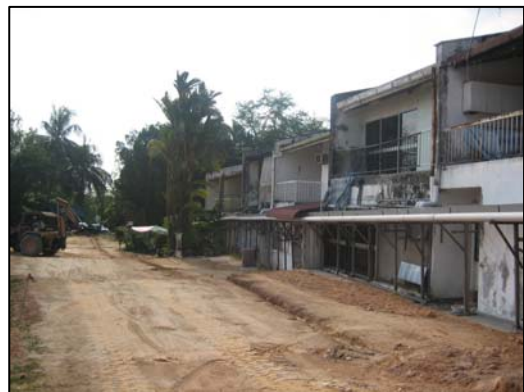
Figure 20k View of earthwork reaching the top at the backyard.

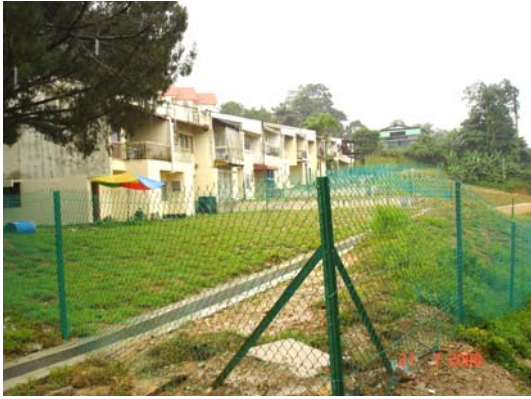
Figure 20l View of rehabilitated spacious backyard

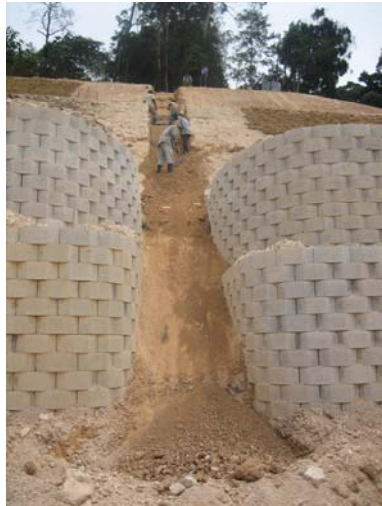
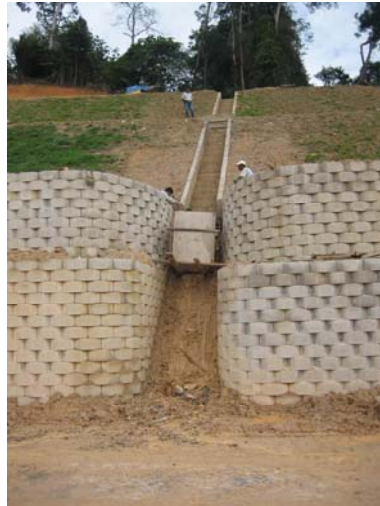
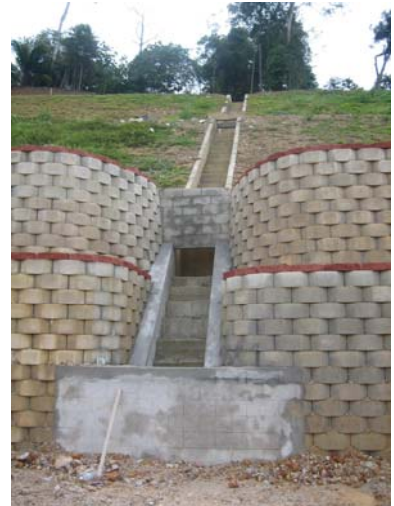
Figure 21i Constructions of slope drainage structures and Modular Block walls in progress.

Figure 21h shows the commencement of rehabilitation works in November 2007. It can be seen that the landslide has encroached into the housing development site. Figure 21i shows the construction of slope drainage and Modular Block wall in progress. The rehabilitation work was completed with turfing in July 2008. The exposed fissures of the boulders were patched with cement mortars and formed part of the landscape features of the upper turfed slope. Figure 21j shows the view of completed slope rehabilitation with Modular Block wall and construction of houses in September 2008. Figure 21k shows the picture of the completed slope rehabilitation, Modular Block wall and houses in April 2009. The construction of houses were completed in October 2008. Modular Block wall, geogrid reinforced slopes complete with drainage and turfing were completed in December 2008. By April/June 2009 all houses were constructed, sold and occupied. This is a project where the purchasers are comfortable with the idea of living near a slope. Throughout the design and construction of slope rehabilitation, public safety and drainage were both amongst the top most priority of the client.

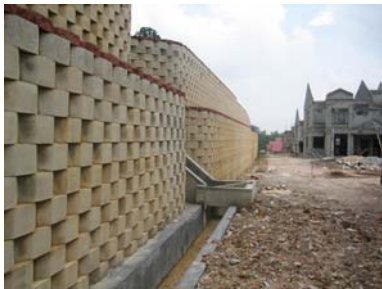
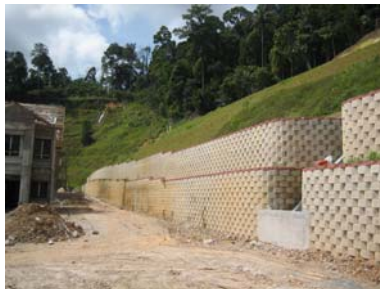
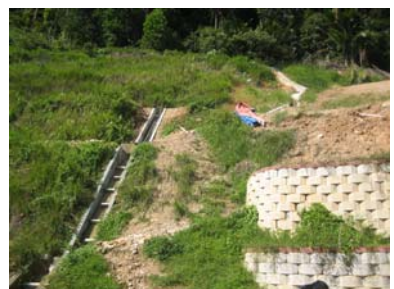
Figure 21j View of completed slope rehabilitation of Modular Block walls and slopes.

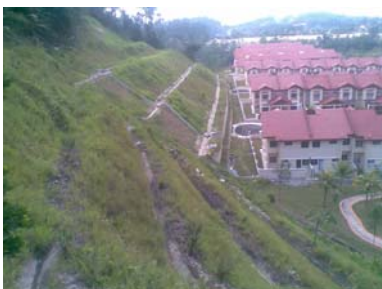
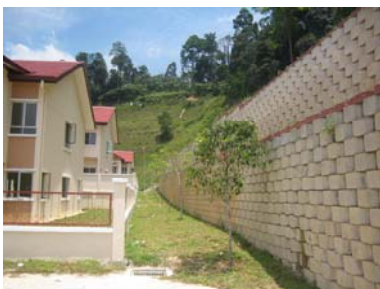
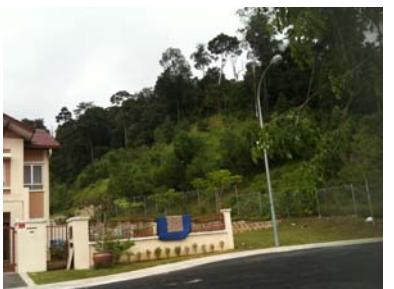
Figure 21k View of completed slope rehabilitation and houses, April 2009 & June 2010
